# Water-Pumping Windmills in Karamoja: A wasted Opportunity

This policy brief investigates the state of the windmills in Karamoja region and highlights key issues for policy consideration.

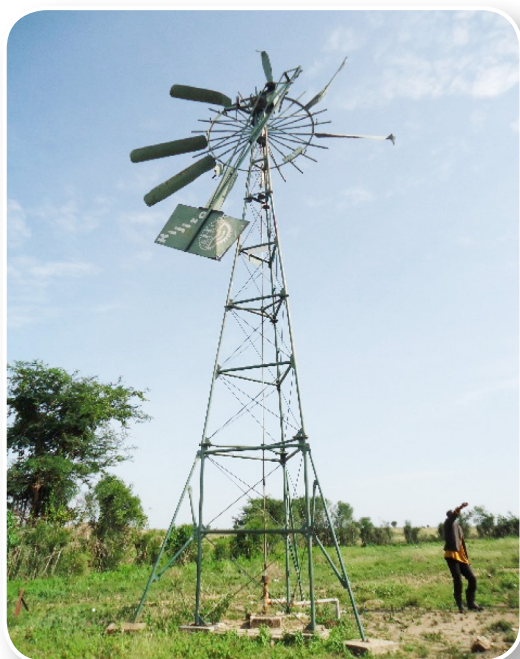
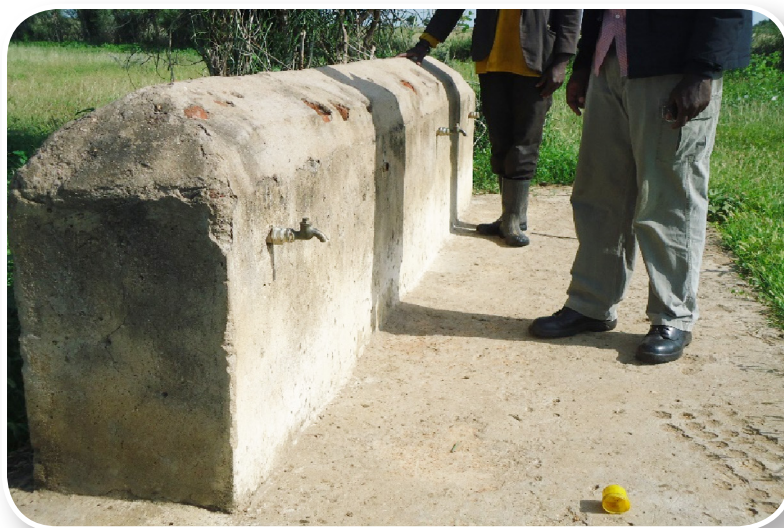
*L-R: Non-functional windmill for pumping water and a tap stand at Rengen in Rengen sub-county*

Ministry of Energy and Mineral Development (MEMD) planned to restore two water pumping windmills in Karamoja region. Only one windmill at Lokitalebeu sub-county in Kotido district was partially rehabilitated while one in Rengen sub-county was not repaired (picture above). Repairs in Lokitalebeu were partially done due to inadequate funding. Majority of the Karamajongs in Rengen consume dirty water from the swamps for lack of alternatives.

There is therefore need for the MEMD to mobilize funds to repair the existing mills, and in the medium term to re-install those destroyed desirably in densely populated community centers to ensure safety of the equipment.

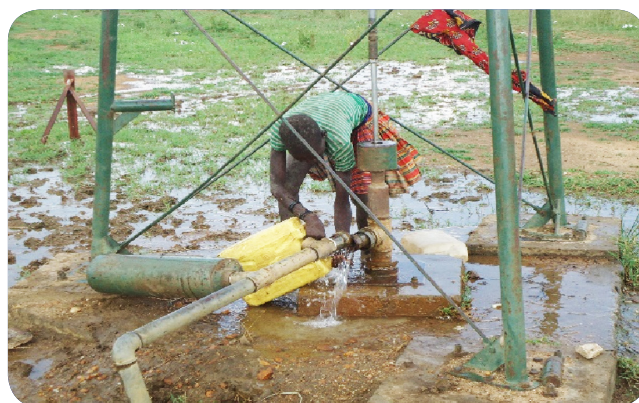
*Leaking pipes at the partially restored windmill for pumping water in Lokitalebeu sub-county, Kotido district*
