THE REPUBLIC OF UGANDA

Semi-Annual Budget Monitoring Report

Financial Year 2014/15

Roads Sub-Sector

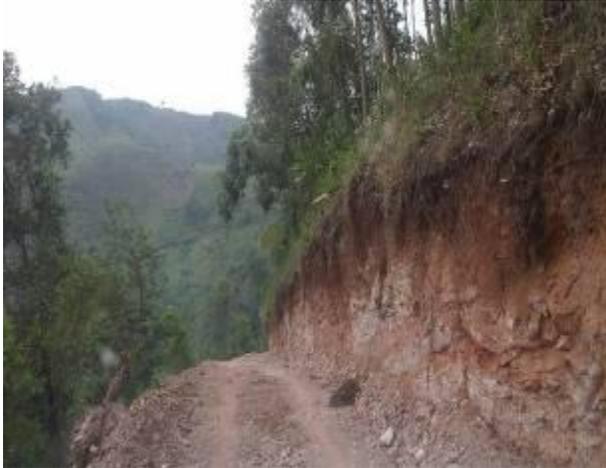
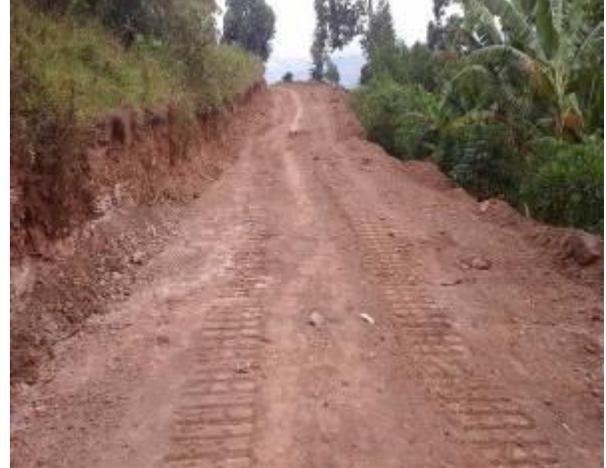
Section along Kikombe Trading centre-Lyashisha-Kyambura river crossing-Mukatojo road which requires deep cuts; Incomplete section along Kikombe Trading centre-Lyashisha-Kyambura river crossing-Mukatojo which has been graded

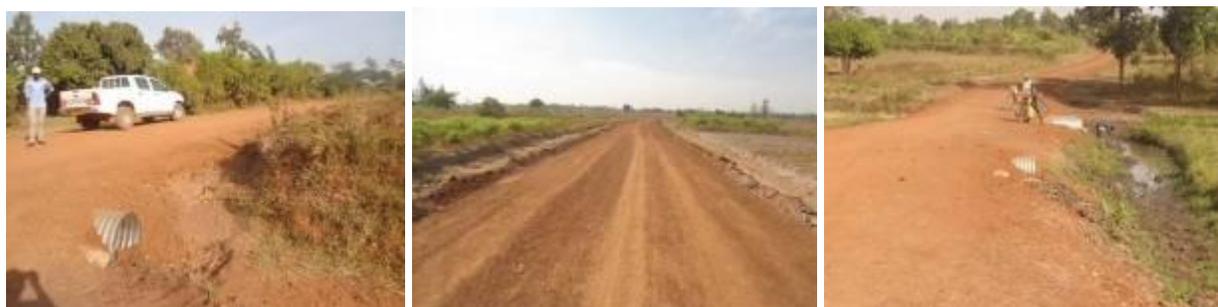
Left: An access culvert and a gravelled section on Mudimbu- Highland road in Mazimasa sub county; Center: A 300m raised swamp section with side drains of 2m width at Km 1+200 on Mazimasa B - Guli road; Right: A raised swampy section along Kachonga-Bufujja road at Km 1+400 in Kachonga sub county

It was observed that the grading, shaping and forming works of the road surfaces were done properly. However, one of the culverts installed along Kachonga-Bufujja road at Km 1+400 in Kachonga sub county was not installed properly.

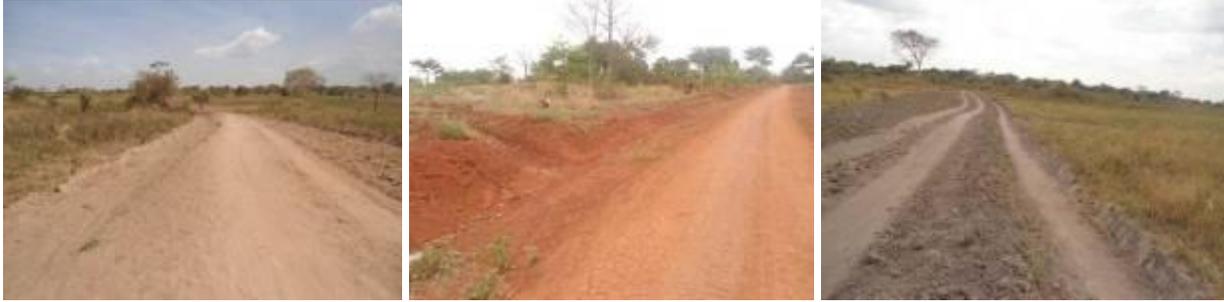
The incomplete activities observed on the project roads were: culvert and gabion installation; back filling using excavated material and filling using approved granular material. It was also observed that there are more offshoots required along the two road sections and the need for more gravel beyond the spot gravelling provided for in the contract. The physical progress of works at the time of monitoring was estimated at 75%.

Left: A swamp section at Km 6.0 along Nsomba P/s-Igalaza road which need to be gravelled; **Center:** A bush cleared and shaped road section with an offshoot at Km 1.4 on Irapa-Kigwesi road; **Right:** A swampy section along Irapa-Kigwesi road between Km 5.4 and Km 7.1 where culverts were to be installed.

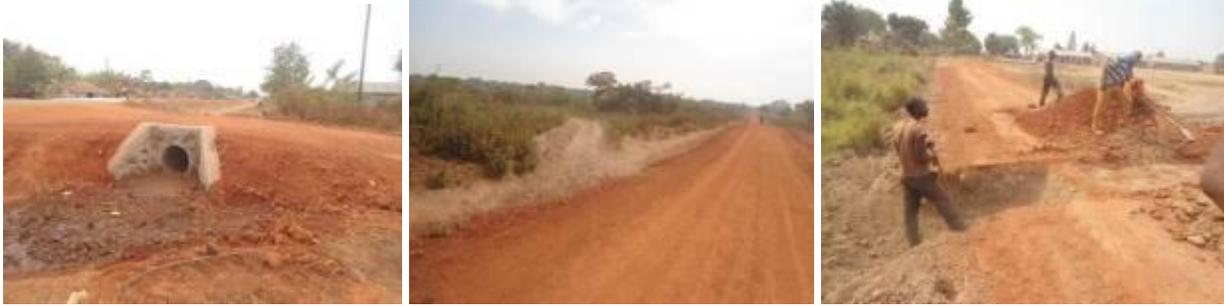
Left: A 600mm diameter access culvert with a head wall at the beginning of the road; Center: A gravelled section with a mitre drain; Right: Excavating for a culvert line along the project road

The road works done were observed to be of a good quality as the contractor adhered to the specifications of the MoWT. This contract works was going to be finished in one month to the end of the project completion date.

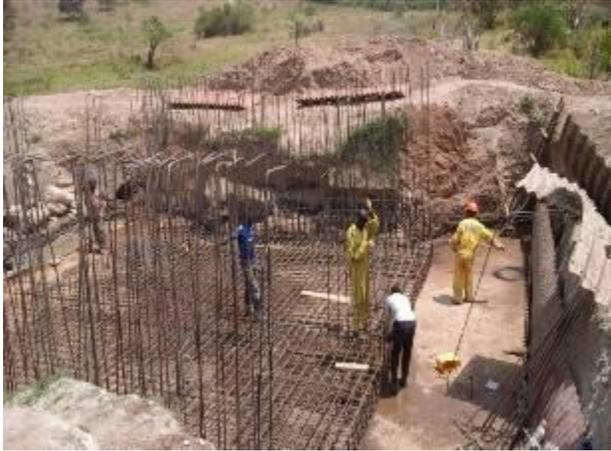
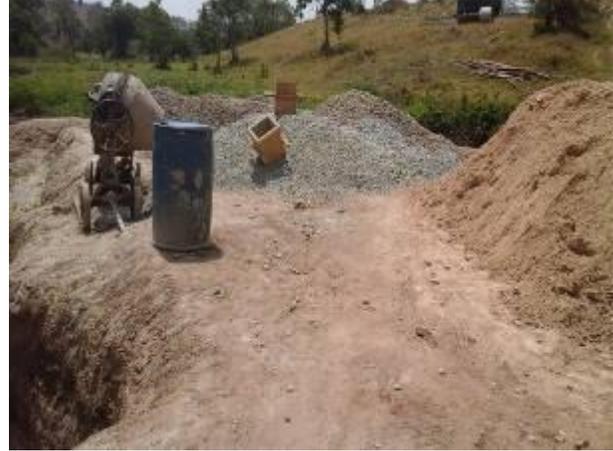
Left: Fixing of reinforcement bars for the bridge and Right: Construction material on site

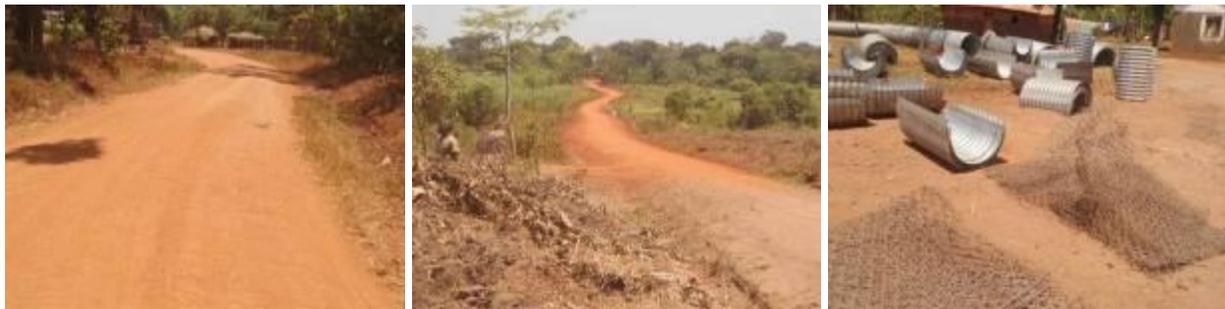
There had also been a delay in the project implementation caused by the MoWT which provided the Armco culverts for the interconnectivity project. The late delivery of culverts on site brought the works to standstill as the contractor could not carry on with some road works until the culverts had been installed.

Kamuli district: Left: A completed section on Musunu-Bulukaire-Nakabala road; Center: A swamp raised and gravelled section on Bukyonza-Bukozi road; Right: Armco culvert material and gabion meshes supplied by MoWT one of the project sites

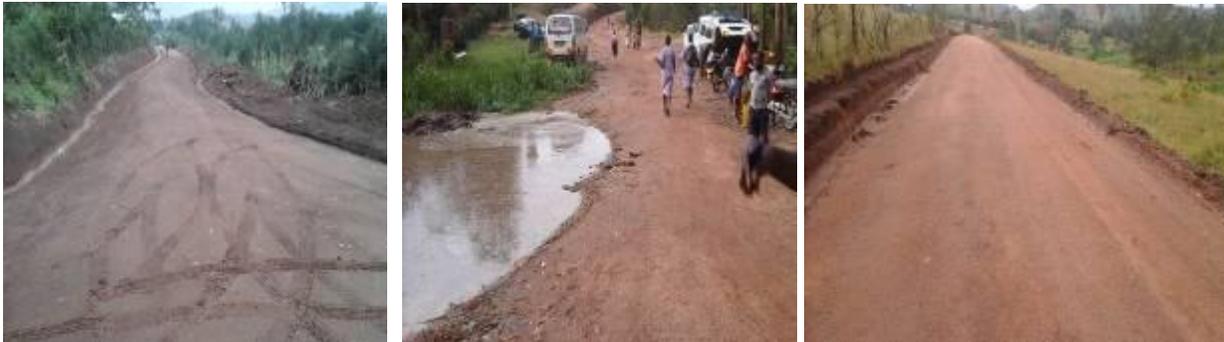
L-R: Graded section of Rukanga Primary School road ready to receive gravel; very well graded section of Nyakatojo – Kabumba section; Unworked on swampy section at 0+200 along Kikonje – Rwashamire road, works have not yet started because of lack of culverts.

- The area experiences heavy rains and these slowed down progress of the earthworks. This is a likely a cause for time extensions on this project.
- The contractor has experienced a delay in receiving materials such as culverts and gabions which according to the contract were supposed to be supplied by the MoWT.
- Delay by the MoWT to certify payment requisitions by the contractor.

- The MoWT should expedite the delivery of materials to avoid further delays
- The MoWT should ensure timely payments to the contractors so as to avoid payment damages associated with such delays.

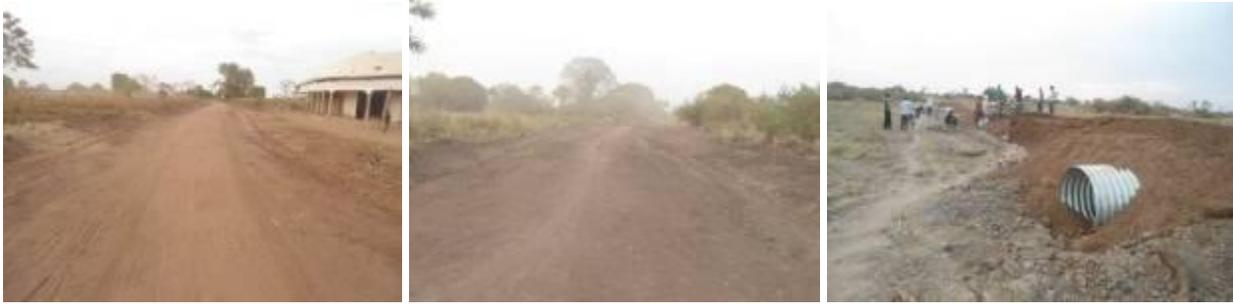
Serere County, Serere: Left: A dusty graded section of Sapir-Ojara-Amakio road in Olio sub county; Center: A bush cleared section at Km 2+200 on Kampala-Kachinga road in Kyere sub county; Right: Swamp raising after culvert installation with gravel at Km 3+400 on Angole-Omagoro-Kachinga road in Kyere sub county

During the Inspection, the following were observed: mitre drains and offshoots on all the two road clusters were not sufficient, undulations and unevenness, some sections which were not properly formed and some culverts not properly installed on Angole-Amagoro-Kampala road.

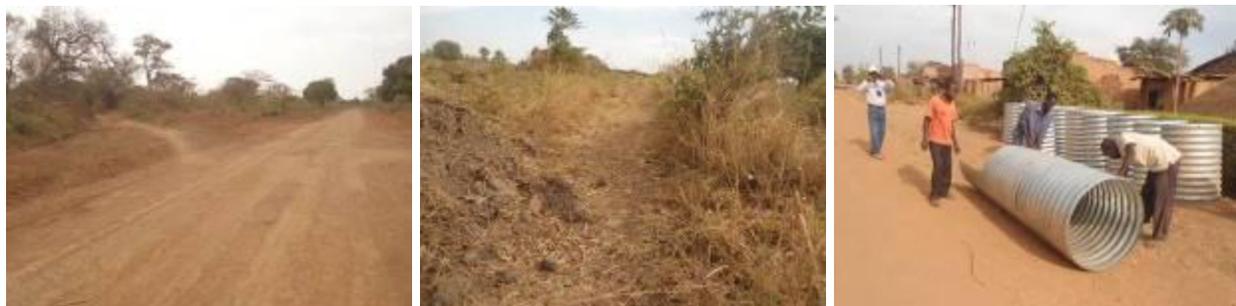
Serere District, Kasilo County: Adwenyi-Toror-Kilembe road: Left: The straightened re-aligned section at km 2+200 with the old section of the road (path) on the left; Center: A section of the old road that was avoided at Km 1+600; Right: Assembling of the Armco culvert pipe culverts at Apapa Police Post

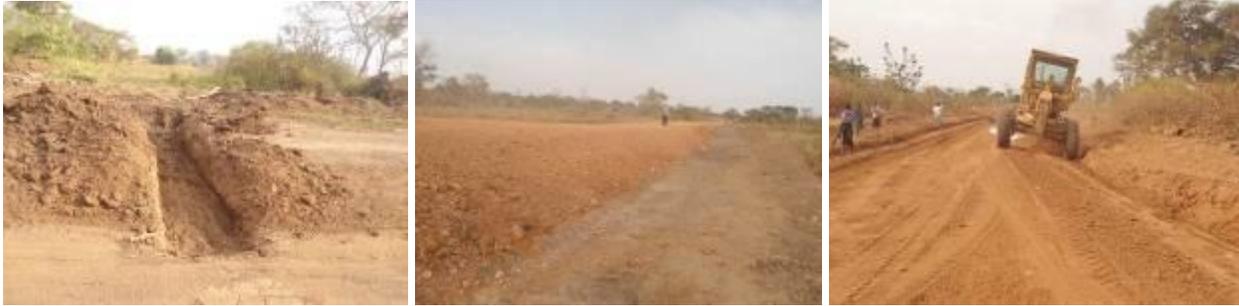
Serere district, Kasilo County, Olwa-Obangin-Otoba road: Left: Excavated trench for pipe culvert installation at Km 4+200; Center: Swamp raising at Km 6+600; Right: Grading and shaping of the road at Otoba

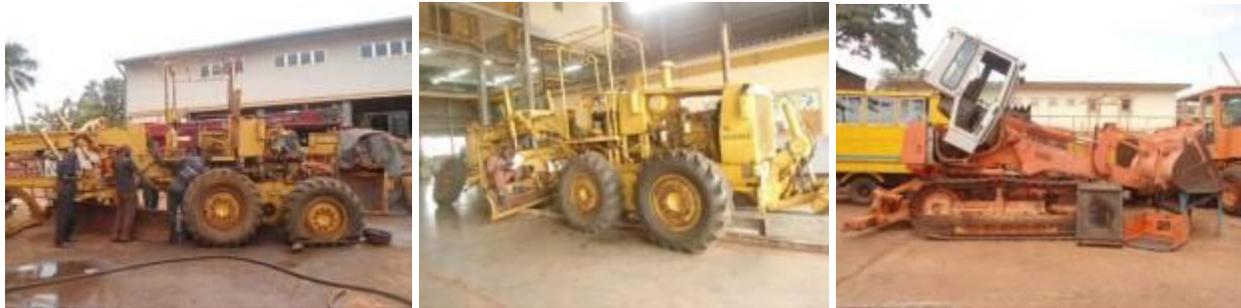
Left: Kamuli motor grader undergoing maintenance; Centre: Komatsu grader from Butambala; Right: Truck excavator from Katakwi

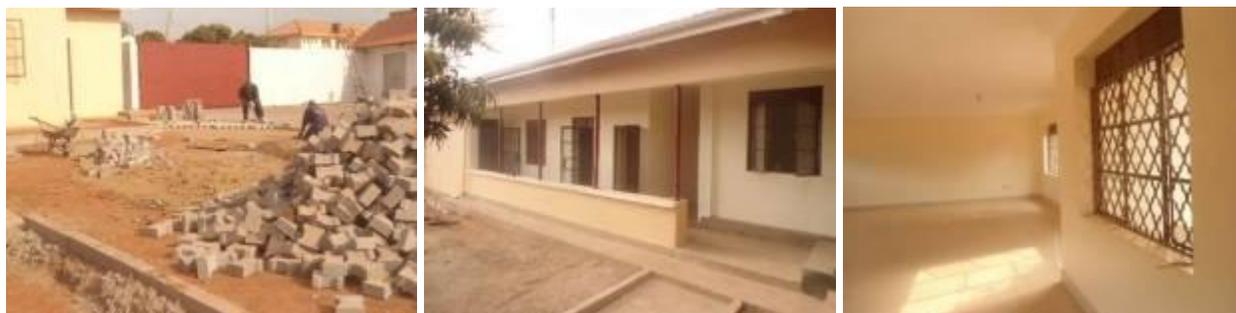
Left: Compound paving works; Centre: Part of the office under renovation; Right: Internal view of the renovated room

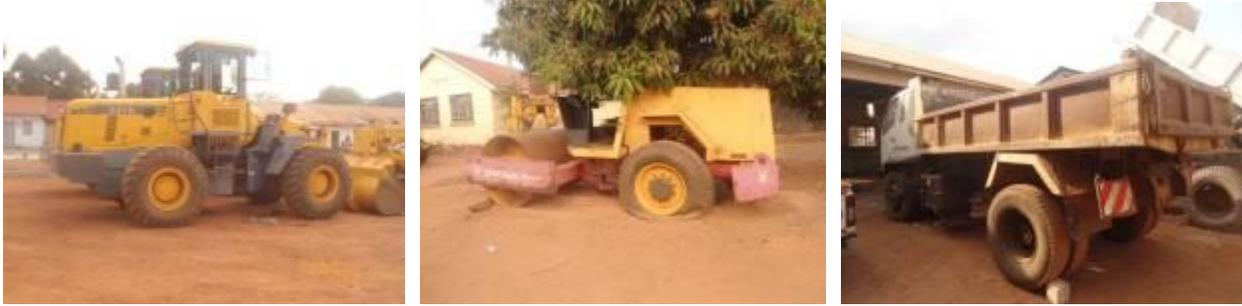
Left: A wheel loader for the MoWT force account unit in Northern Uganda; Centre: A dynapac roller from Kotido district to be boarded off; Right: A repaired dump truck from Adjumani district that is awaiting to be sprayed

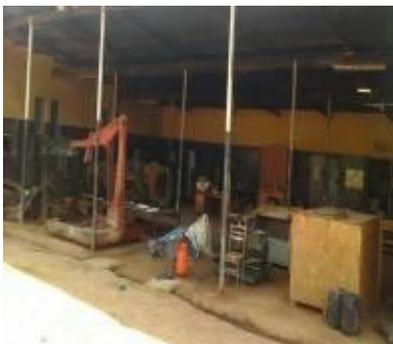
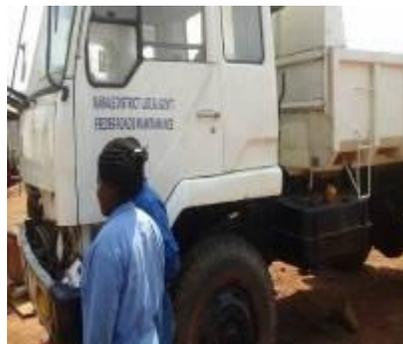
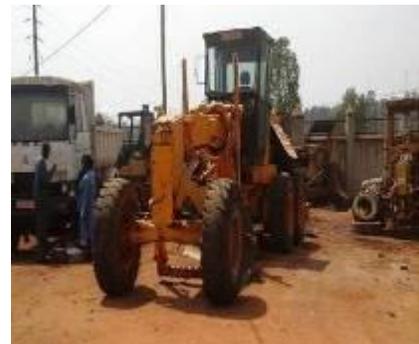
L-R: Part of the un-stocked workshop; A truck belonging to Kabale district which had been brought for repairs; One of the graders from the local governments brought for repairs at the workshop

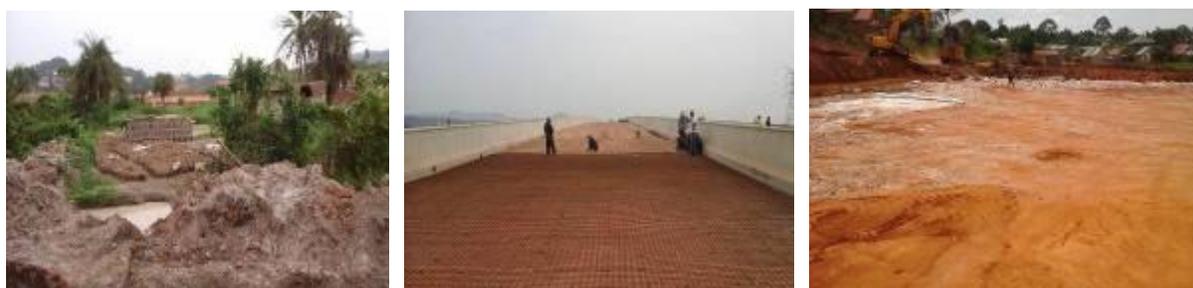
L-R: Obstruction of works at km 9+100 by fish ponds; Fixing of reinforcement at Busega Bridge; Earthworks ongoing at km 24+500

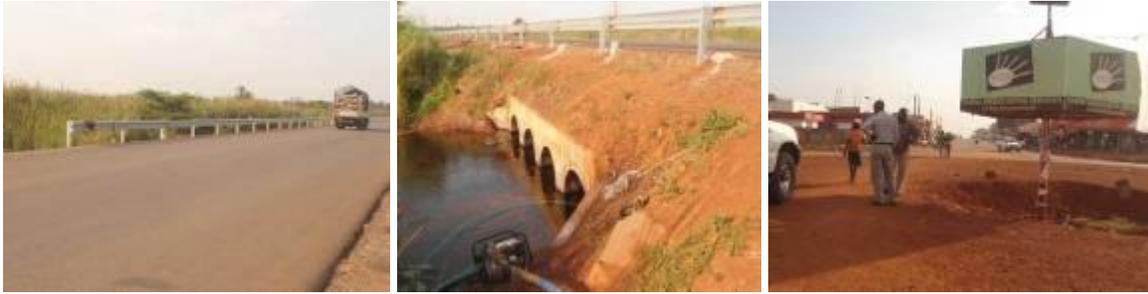
Left: Guard rails at km38+000; Centre: four pipe culverts at km 38+000; Right: Kamuli round about where the road ends at km 58+000

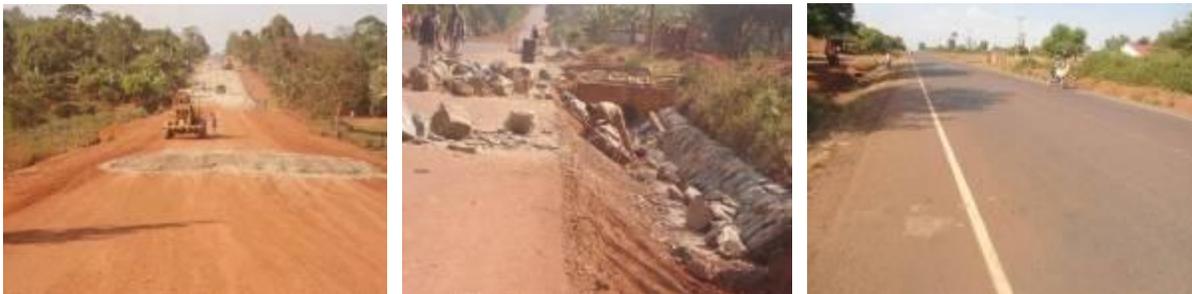
Left: A section still under construction at Km 9+000; Centre: Stone pitching works at km 6+186; Right: A trial marked section at km 24+990

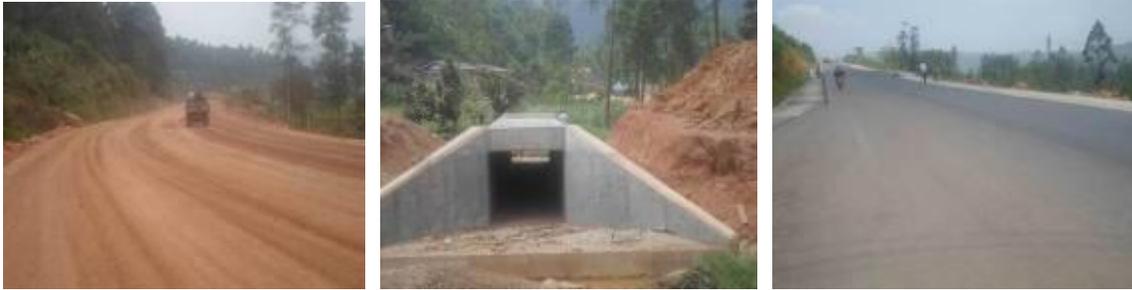
Left:A completed improved sub-base at km 152+312; **Centre:** A completed box culvert at 4km from Katuna; **Right:** A completed section of the road at km 100+300

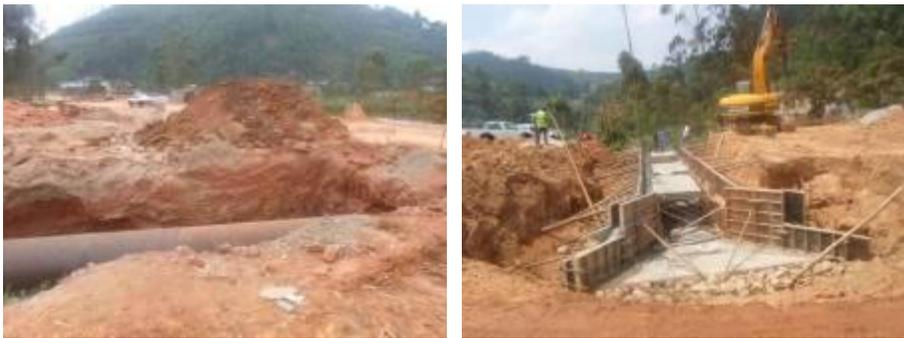
Left: Armco culverts yet to be constructed at km 155+628; **Right:** A box culvert under construction at 1.4km from Katuna

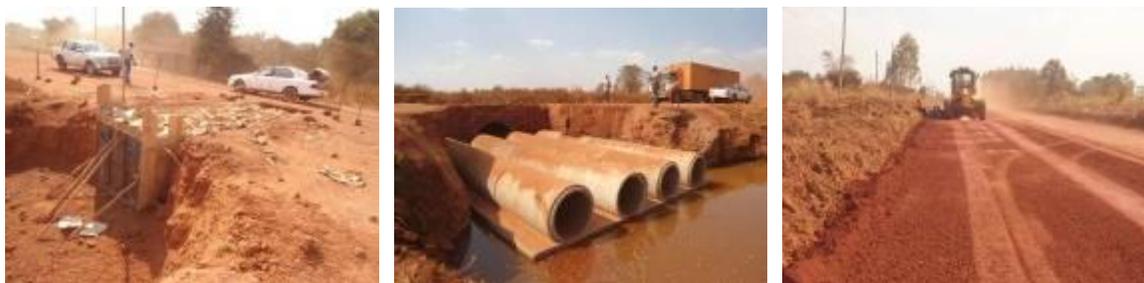
Left: culvert under construction at km 1+518; Centre: four lines of culvert at km 2+944; Right: A milled section at Km 19+545

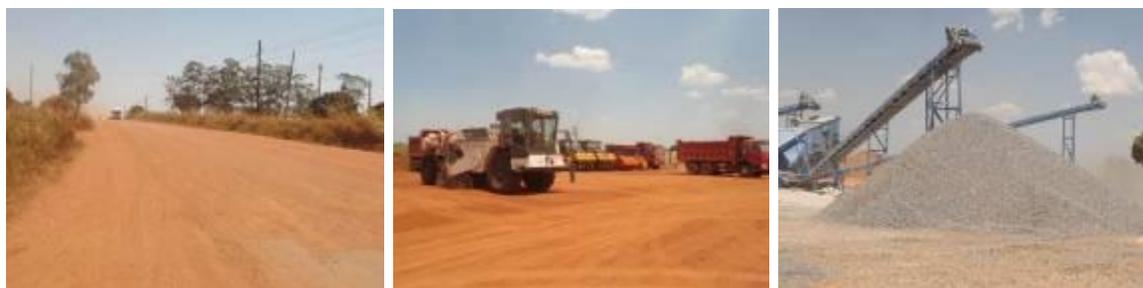
Left; Milled section at km 0+000; Centre: Equipment at camp site at 30+500; Right: A crusher at km 38+000

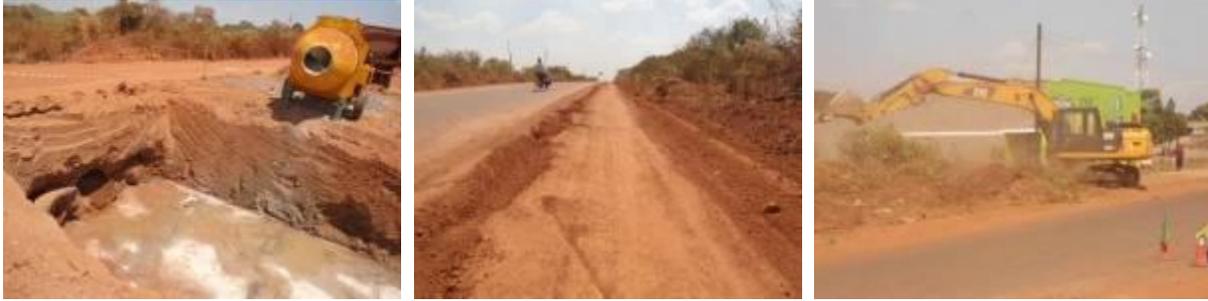
Left; excavation works for a culvert at km 2+370; Centre: rehabilitation of road shoulders at km 40+419; Right: Bush clearing with an excavator at km 59+000

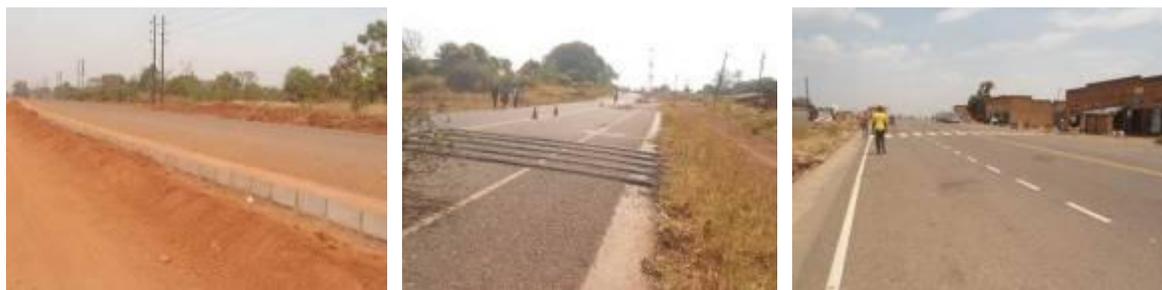
Left; Concrete lining along the road edge at km 0+800; (Centre): Rumble strips;(Right):A completed section at km 35+174

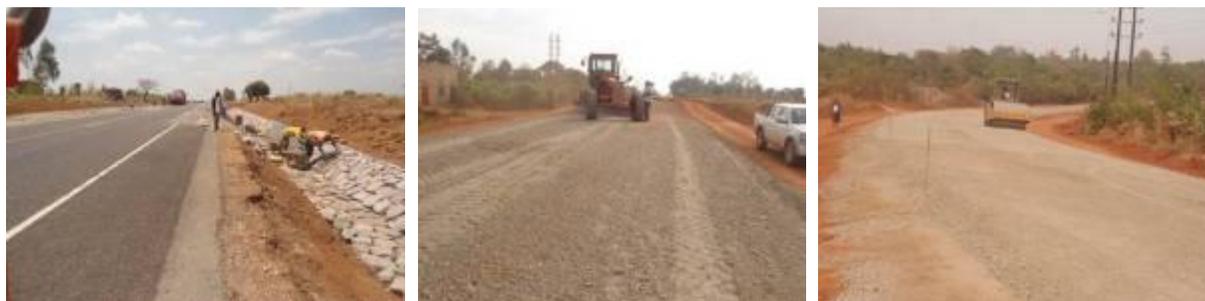
Left; Stone pitching works at km 35+580; Centre: spreading of road base material at km 1+200; Right: compacting of road base at km 1+100

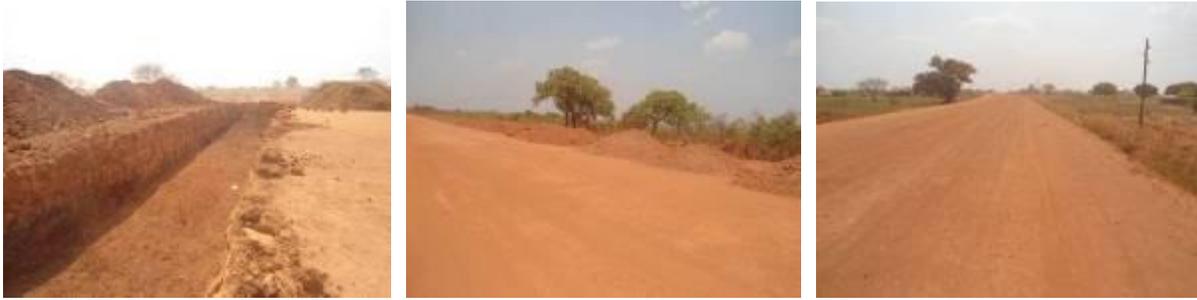
Left: excavation for pipe culvert at Km 96+430; Centre: Dumping of sub base at km 82+300 ; Right: milled section at Km 70+000

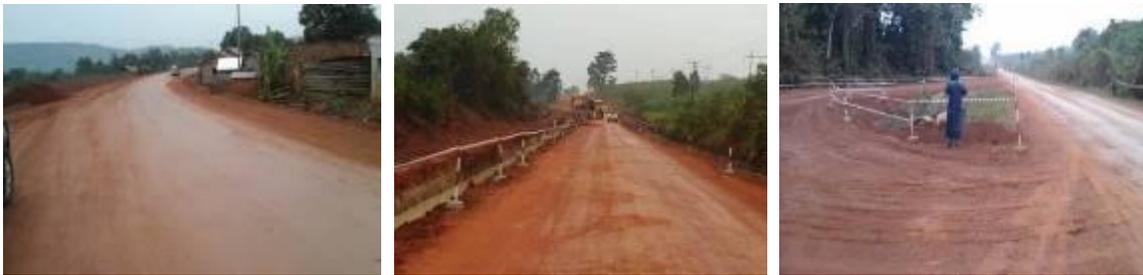
Left: completed subgrade section; Centre: ongoing earthworks; Right: Swamp section on km 12+600 awaiting rock fill

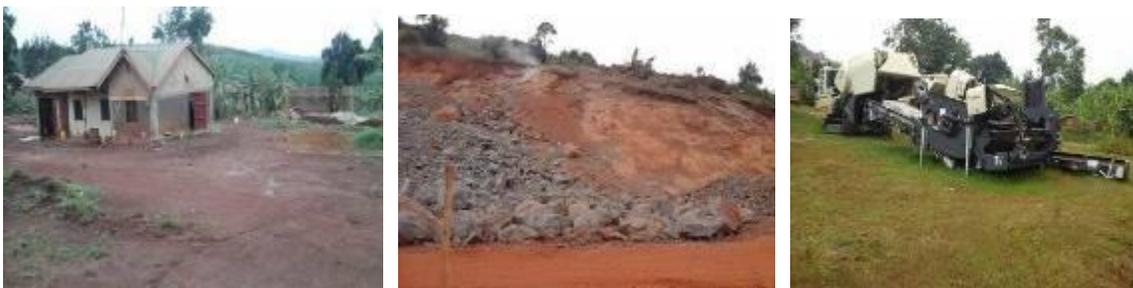
Left: Houses along the road still awaiting compensation; Centre: A quarry site at km24; right: crusher plant to be assembled

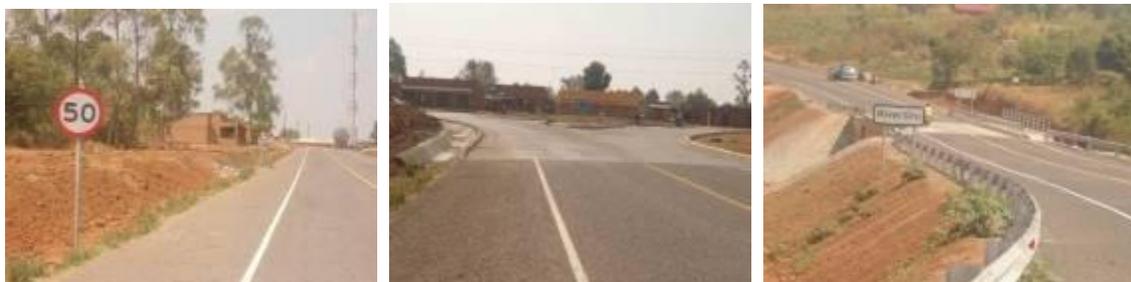
Left: Sign post at Km 35+500; Centre: A concrete pavement on a roundabout at Koboko; Right: A bridge at River Oru

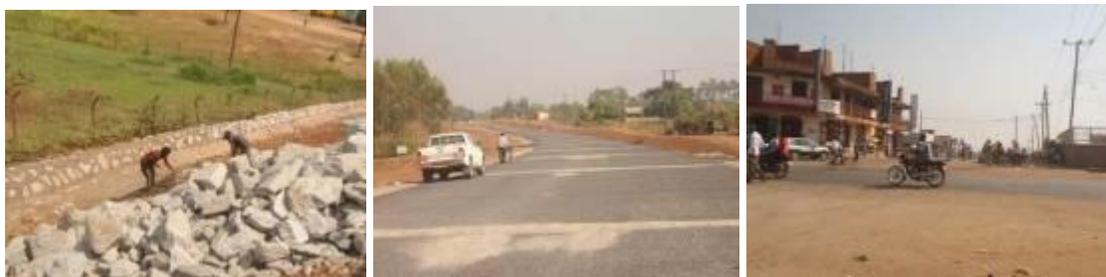
Left: Stone pitching works at Km 69+000; Centre: A section where the 1st seal had been done; Right: One of the building in Arua town junction which has obstructed round about construction

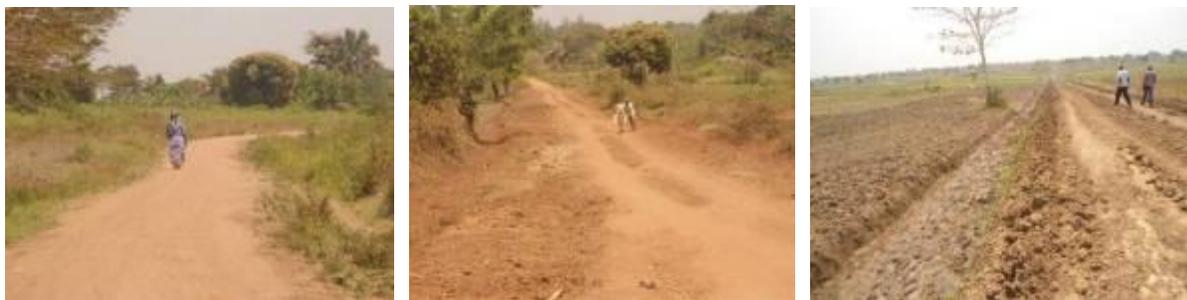
Budaka District: Left: A section of Kabuna-Nansana-Kebula road; Centre: A graded section of Nalera-Kiryolo road; Right: The swamp raising done using manual labour on Nalera-Kiryolo road

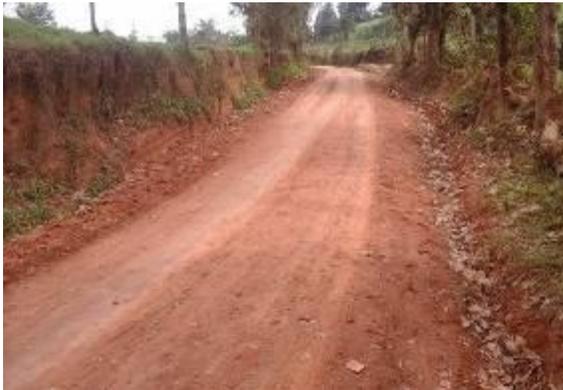
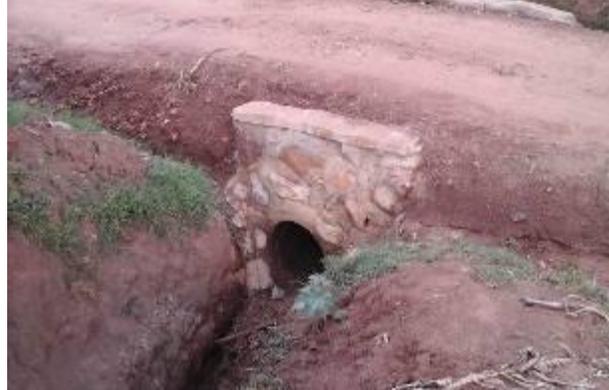
Kaziho – Nyakabanga – Kyabugimbi road (7.5km): The estimated budget for the works was Ug shs 8.25 million. The planned scope of works was to grading and spot gravelling. The road works were completed at a total of Ug shs 8.238 million (99.9% of the budget).

Bushenyi District: Left: Completed section along Kaziho – Nyakabanga – Kyabugimbi road; Right: Completed cross culvert line at km 7+300 along Rwentuha – Kabuba road

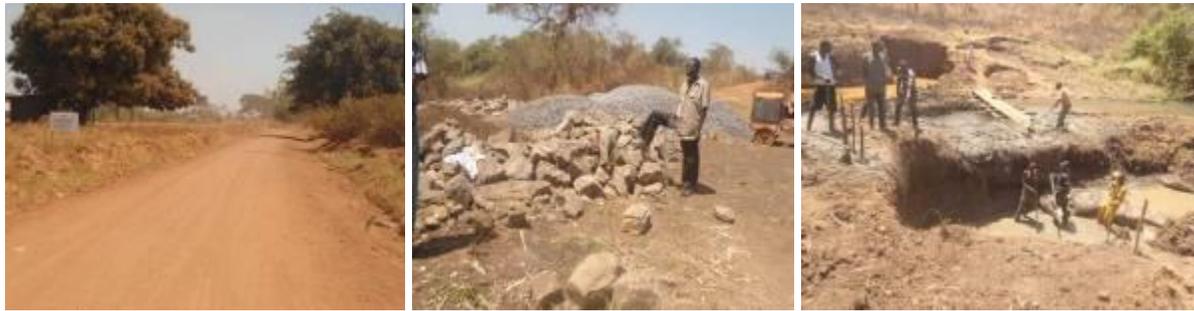
Gulu District: Left: Opit-Awoo road - A graded section at Km 11+100; Centre and Right: Odek Bridge – Construction materials on site and Excavation for the abutments

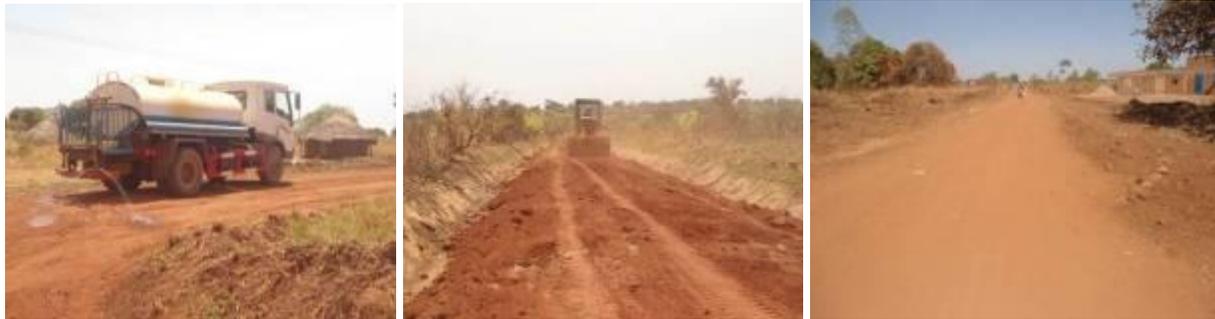
Gulu District: Left and Centre, Lalogi – Bario road - Gravelling activities of watering and spreading; Right: Laroo-Pageya road- Bush cleared section

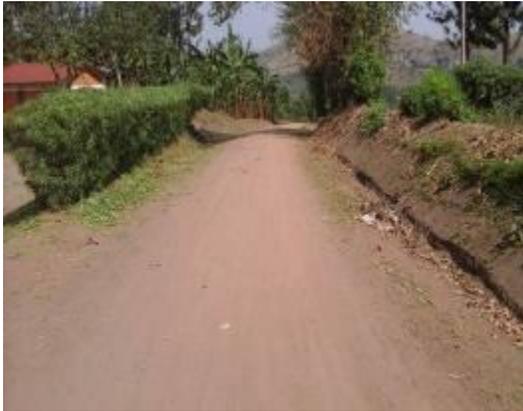
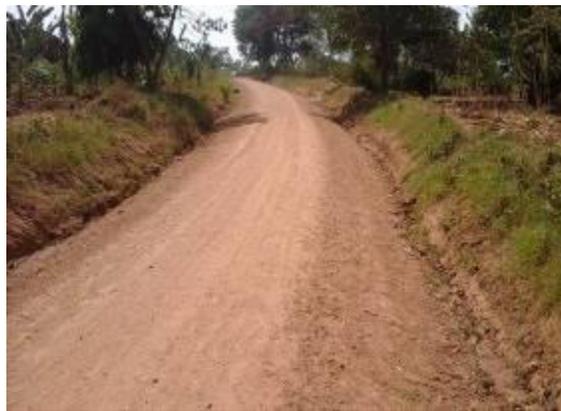
Kashasha – Nyakahama (13km): the planned activities were: full grading, spot gravelling and installation of 29m of culverts at a budget of Ug shs 20 million. The works were completed in

Q2 at Ug shs 50.354 million. The overrun was attributed to the fact that all the works which had been planned for Q3 and Q4 on this road were lapped and done once. Therefore no maintenance activities will be carried out in Q3 and Q4 on this road.

Ibanda District: Left: Graded section of Birongo – Kinagamukono – Kyekanga road at km 5+600; Right: Gravelled section of Kashasha – Nyakahama road at km 4+000

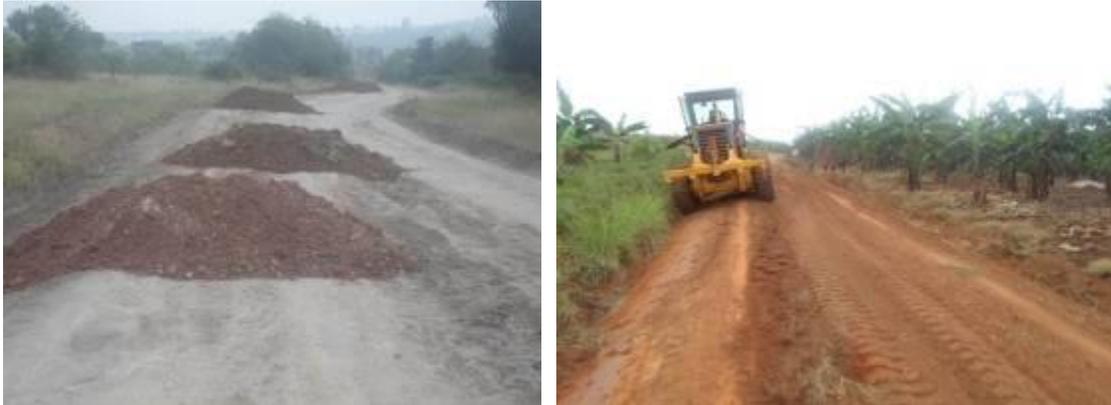
Isingiro District: Left: Dumped gravel at km 7+300 along Kyanyanda-Kihanda-Rwenshekye; Right: Grading works along Ngarama-Kakamba-Omukatogo road

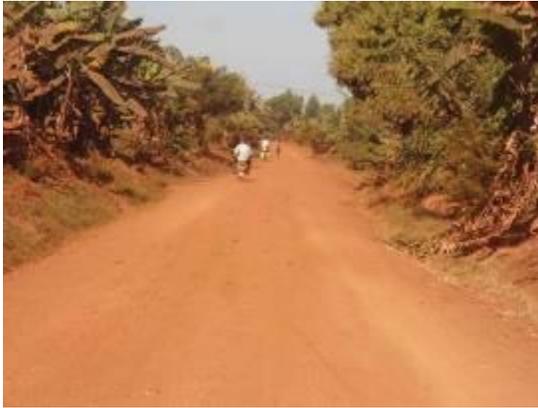
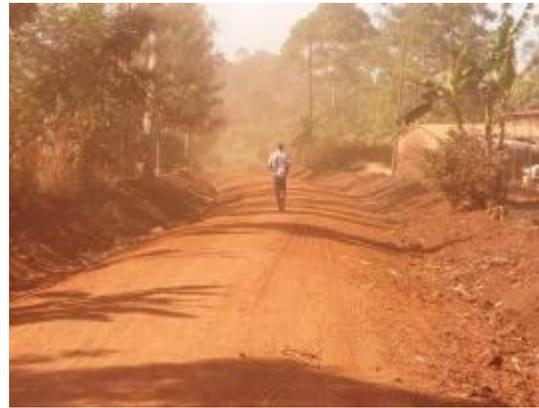
Jinja District: Left: Complete section of Namulesa-Ivunamba at Km 1+500; Right: Completed section of Wakitaka –Kabemba at 0+000

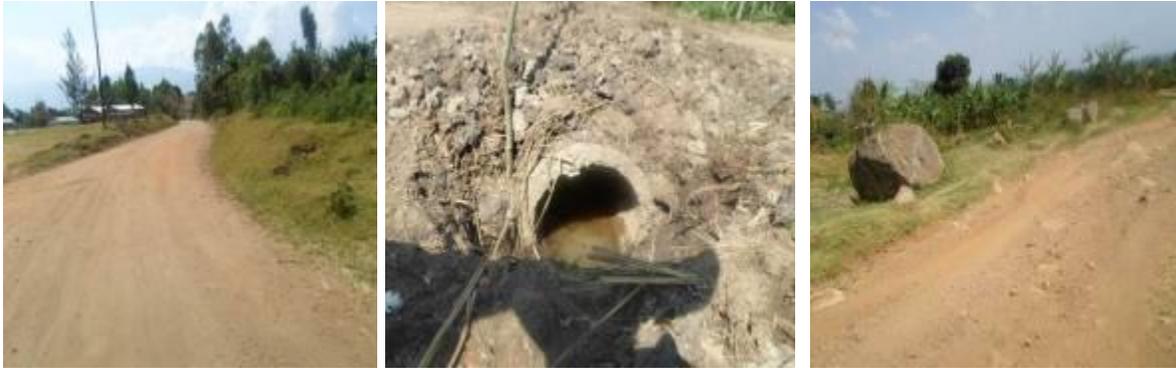
Kabarole District: Left: Graded section at km 2+000 along Kiburara – Kichwamba; Centre: incomplete culvert at km 4+400 along Buhesi – Mitanda road; Right: Rocky section along Katoma – Bwabya road

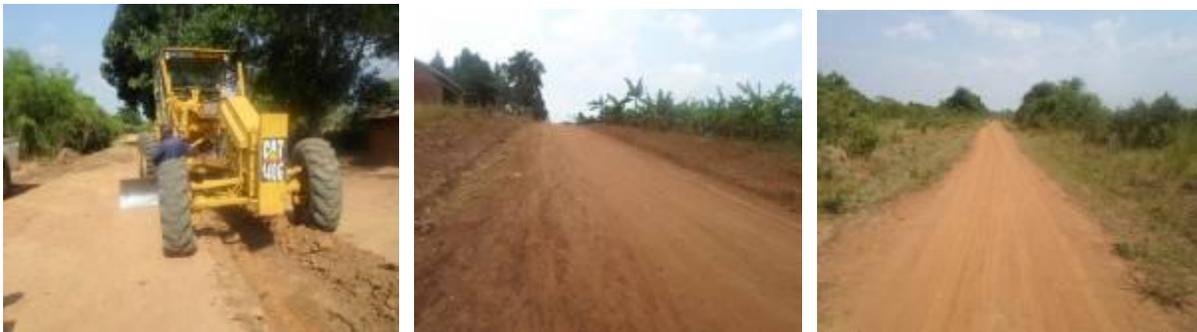
Kiboga District: Left: Grading using a hired grade along Bulyankuyege - Kibisi – Kigwanya road; Centre: Graded section awaiting graveling along Jokero - Nakasozi – Kibulala road; Right: Completed section of Kajjere - Nakasagazi – Mulagi road

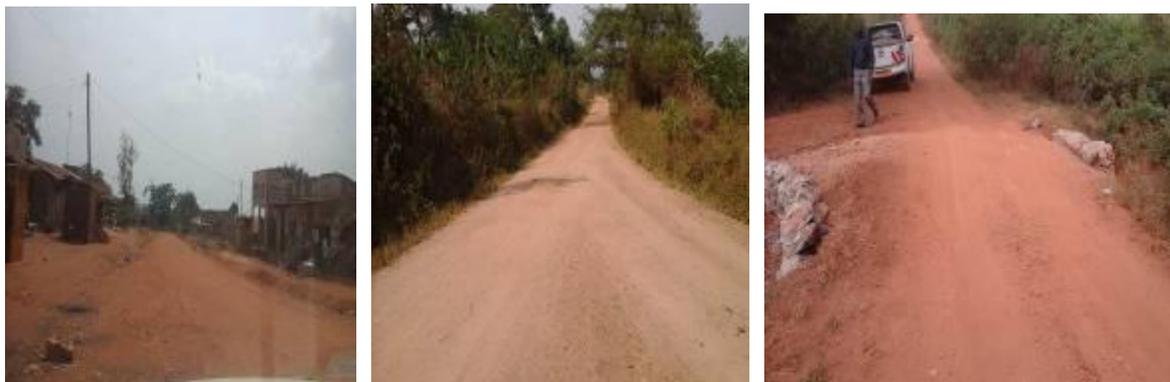
Luweero District: Left: Graded section of Buzibwera-Makangonyigo road; Centre: Gravelled section along Bukembya-Nakusubyaki road; Right: Culvert structure without wing walls at km 5+00 along Bukembya-Nakusubyaki road

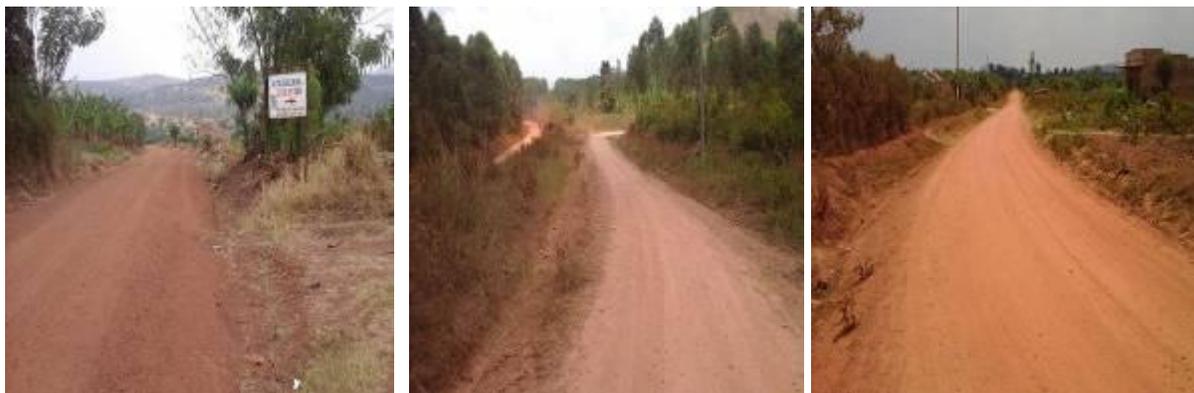
Lyantonde District: Left: A Graveled section at km 11+300 along Kasambya – Kitazigolokwa road; Centre: Graded section at km 7+300 along Kiyinda – Kitesa - Twafanda road; Right: A graded section along Karagala-Kitovu road

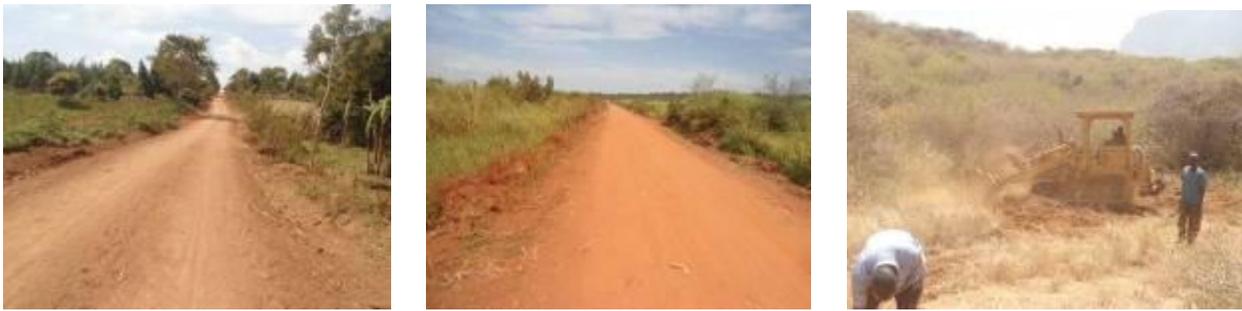
Mayuge District: Left: A graded and shaped section of Kaluuba-Luuba road; Centre: A regravelled section in a swamp at Km 2+900 on Kaluuba-Luuba road; Right: A graded section at Km 2+400 on Bugade-Bukoba road

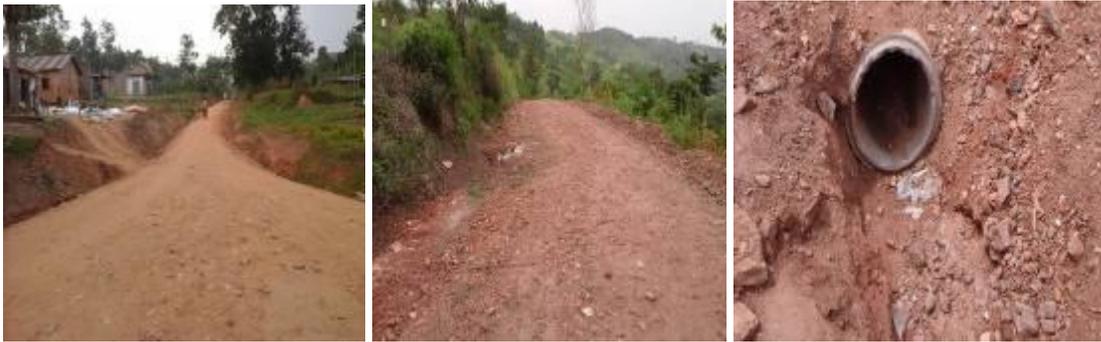
Mityana District: Left Gravelled section along Naama – Buswabulongo road; Centre: Loose gravel at km 3+000 along Mpiringwa - Kasenyi road; Right: incomplete culvert end structure at km 2+800 along Mpiringwa - Kasenyi road

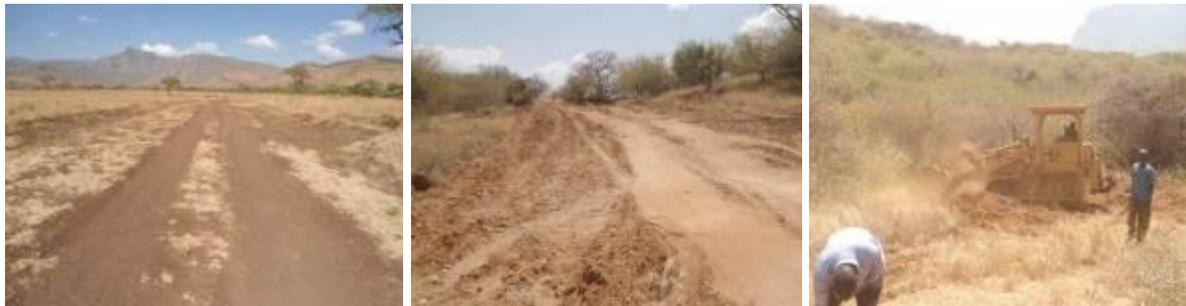
Moroto District: Left: A bush cleared section of Kodonyo-Lorengedwat road at Km 2+300; Centre: A Bush cleared section of Nakabaat-Narengenyia road; Right: A bulldozer clearing the bush on Nakabaat-Narengenyia road

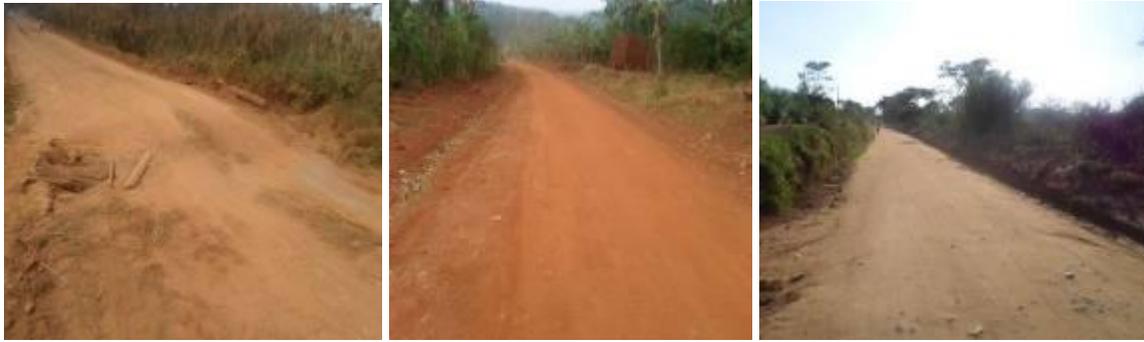
Mubende District: Left: Section at km 13+700 in need of replacement of drainage structures; Centre: Graded section of Kitovu – Lwabusana at km 2+100; Right: Graded section of Musozi – Kalamba road at km 9+600

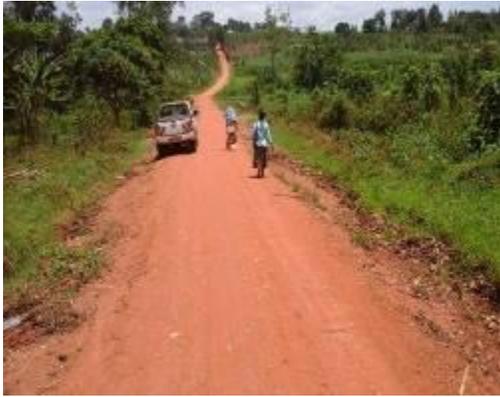
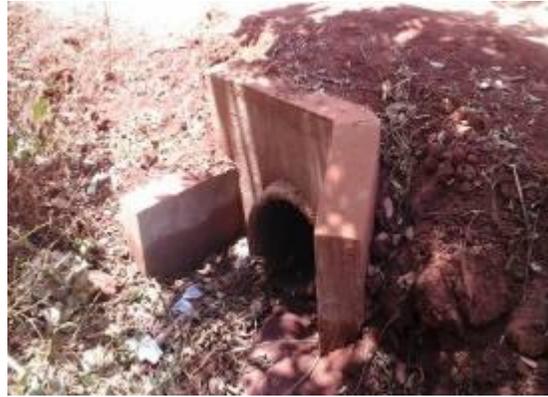
Mukono District: Left: Graveled section at km 6+100 along Namataba – Kanyogoga road; Right: A well completed culvert end structure at km 0+300 along Namataba – Kanyogoga road

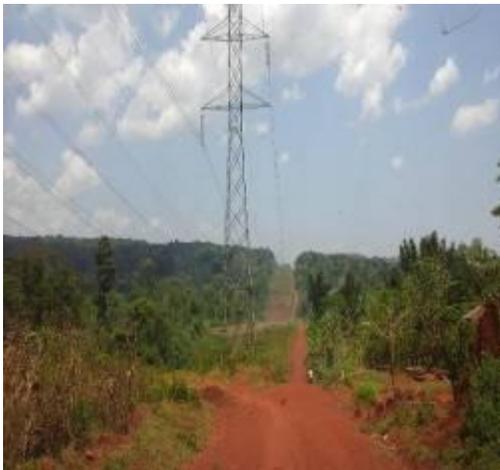
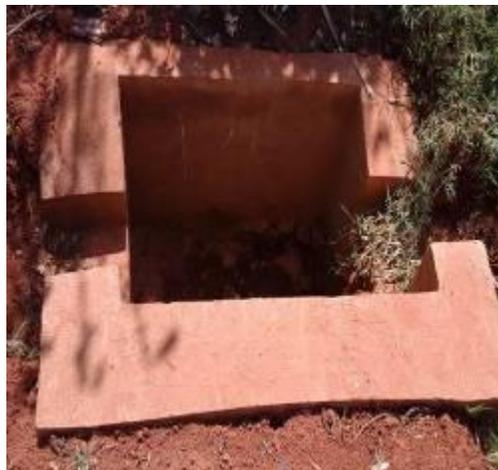
Mukono District: Left: A well gravelled Wagala – Wasswa road at km 6+400; Right: A well culvert completed end structure along Mbalala – Seeta road

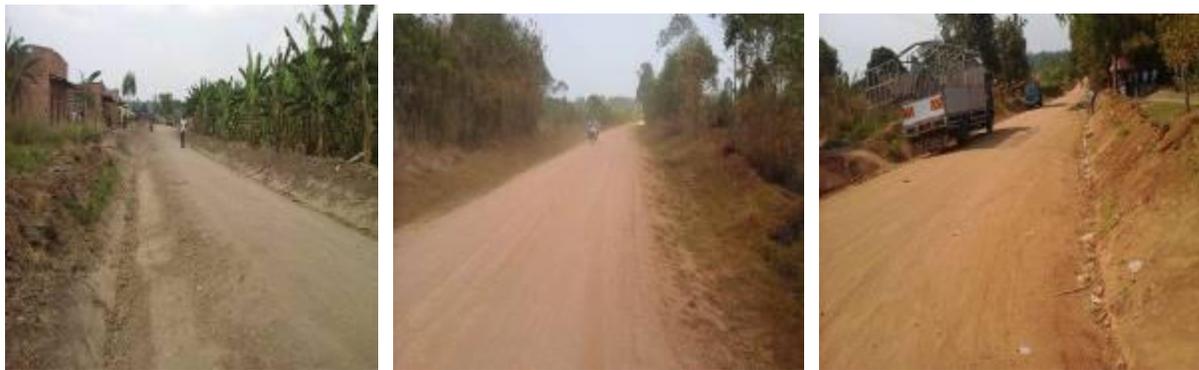
Rakai District: Left: Graded section at km 4+900 along Kagamba-Baale road; Centre: Graveled section at km 3+800 along Kyotera-Betherem-Kalisizo; Right: Graded section at km 7+100 along Bikira-Nvubu-Nakatogo road; Graded section along

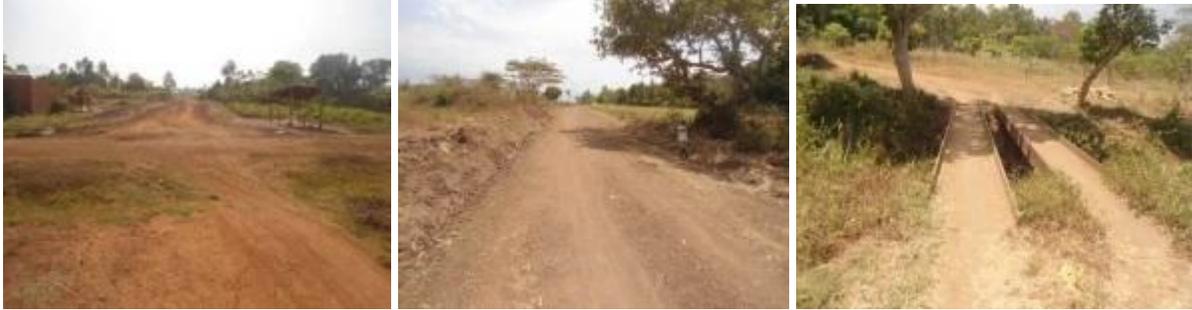
Sironko District: Left and Centre: Graded and shaped sections of Sironko Town Council – Kumira – Kilembe road; Right: I-sections used for the temporary crossing at the Soloni bridge crossing

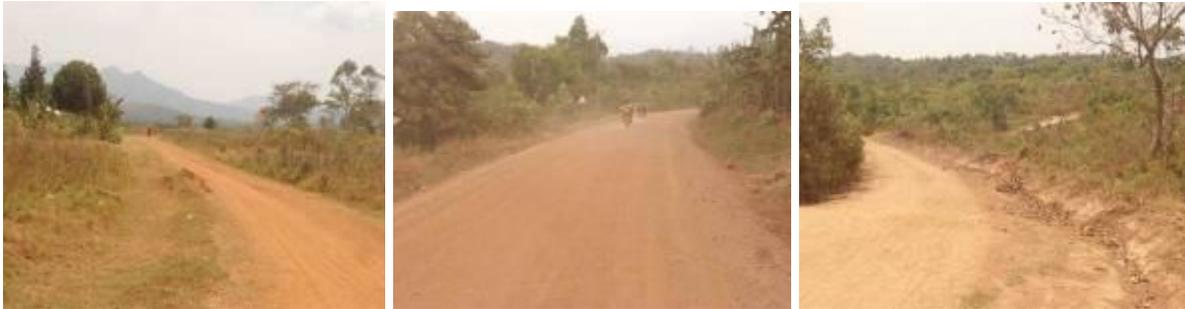
Sironko District: Left: A slashed section on Bukiyi-Kibembe road; Centre: A graded section on Bumundu-Namanyonyi road; Right: A graded section on Nampanga-Buwalasi road

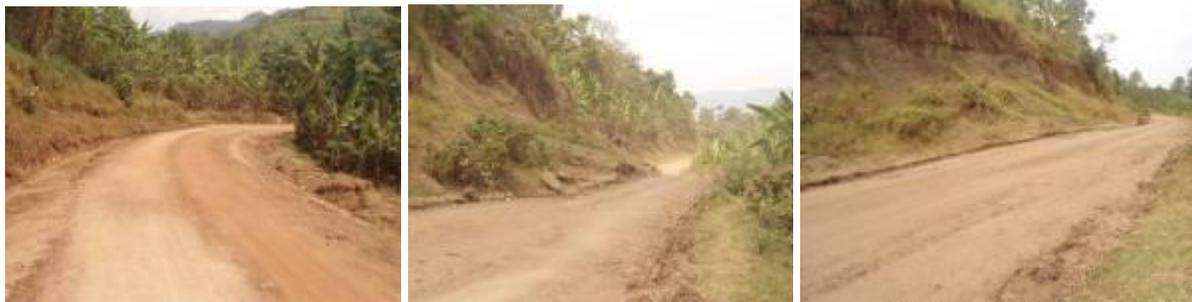
Sironko District: Bweri-Bumunulo road; Left: A graded section of the first 4kms; Centre and Right: A section at Km 5+200 which was affected by landslides

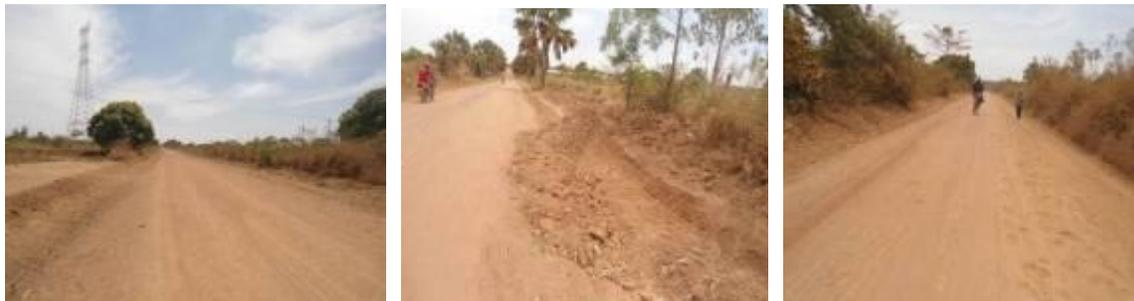
Soroti District: Left: A graded and shaped section of Aponyi-Obito Road (6km); Centre: An offshoot at Km 14+100 on Soroti-Lalle road; Right: A defective section with dust on Asuret-Amagoro road at Km 8+500
