THE REPUBLIC OF UGANDA

Semi-Annual Budget Monitoring Report

Financial Year 2014/15

Roads Sub-Sector

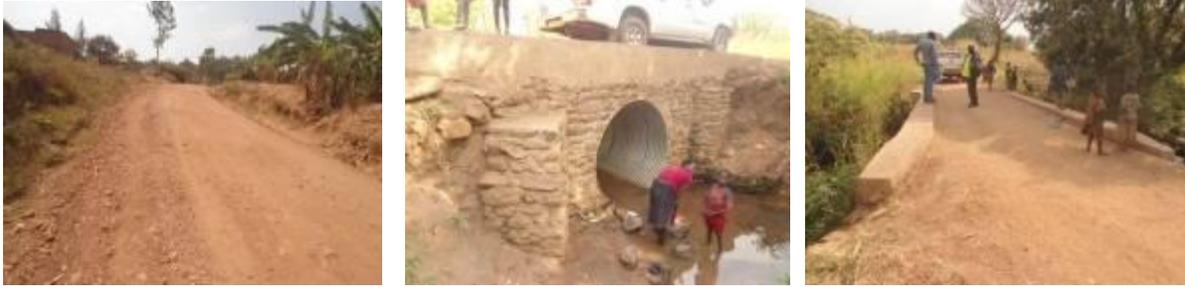
Zombo District: Left: Section of Ayuda-Pakadha-Padea road that was worked on; Centre: Side view of Nyadiel Bridge; Right: Top of Nyadiel bridge

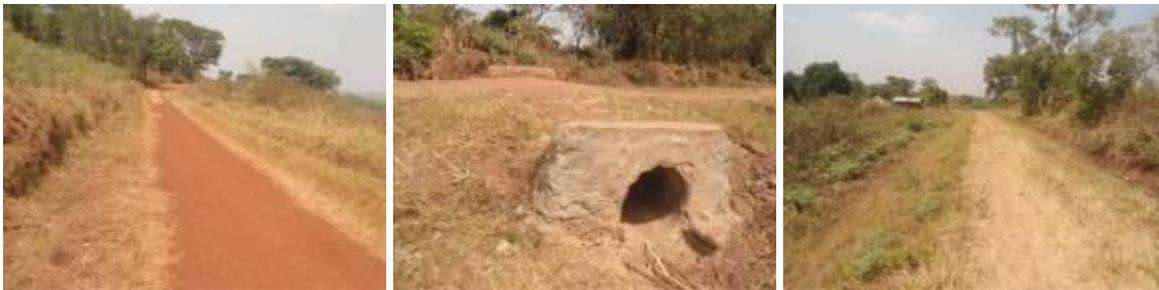
Zombo District: Left: Section at Km 0+000; Centre: A culvert installed at km 5+500; Right: Section at km 5+500 with outgrown grass along Ukemu-pei-Zii road

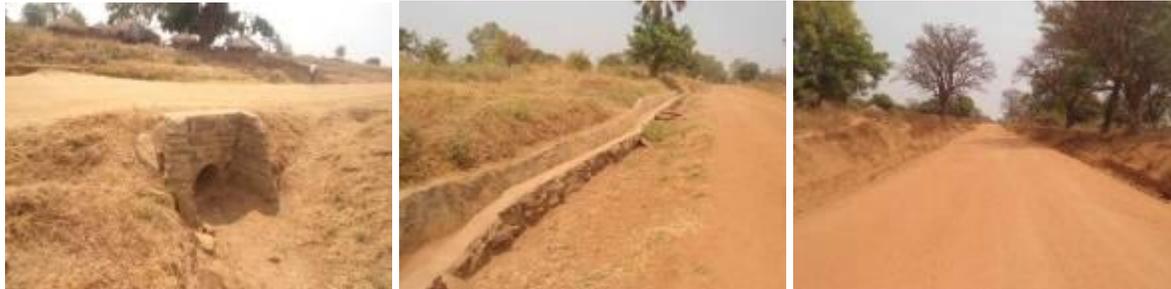
Arua UNRA Station: Left; A concrete culvert installed at km 2+500: Centre; A stone pitched side drain at km27+500: Right; A Front view of the road at km 38+000

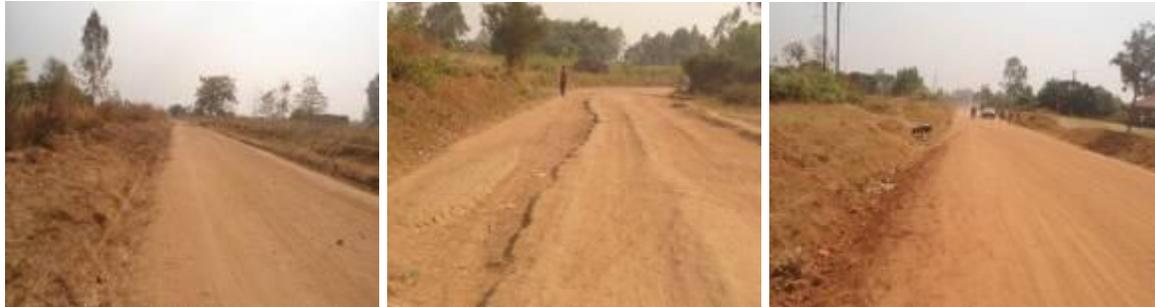
Arua UNRA Station: Left; Graded section at Km 4+400 along Arua-Biliaffe-Otrevu road: Centre; A damaged section at km 7+600 along arua-Girigiri-Ovision road: Right; Graveled section at Km 0+000 along Manibe-Wandi road

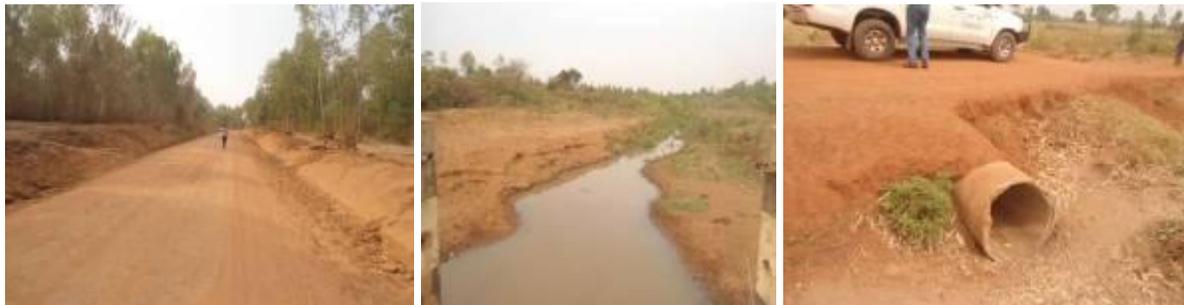
Arua UNRA Station: Left; Back view of the Arua-Muni NTC road at km 0+900: Centre; A River at km 2+100 where training was carried out: Right; A newly installed culvert along Owaffa-Kubala-Omugo at Km 12+300

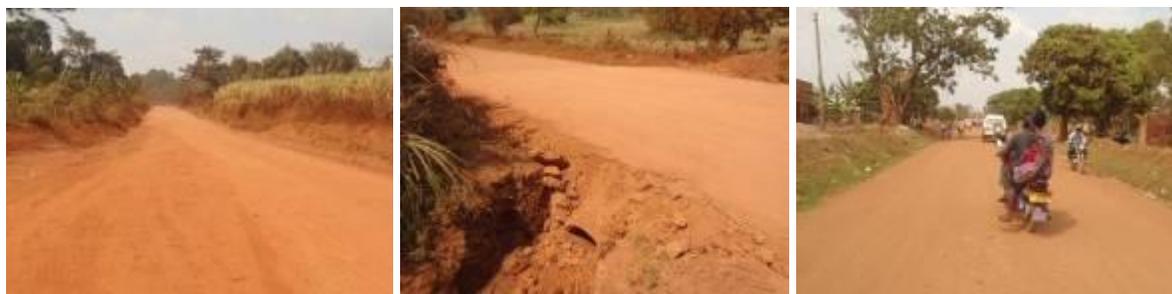
Jinja UNRA Station: Left; A section at km 5+200 along Mayuge-Bugadde-Bwondha: Centre; An installed culvert at km0+800 along Mayuge-Bugadde-Bwondha: Right; Mayuge-Iganga road at km 19+800

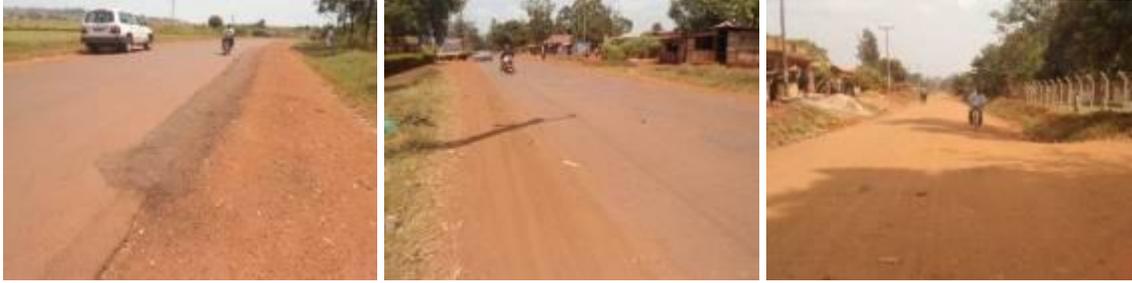
Jinja UNRA Station: Left; Patch works along access to Kimaka Military Academy road: Centre; A recharged shoulder along Access to Kimaka Military Academy road: Right; A section of Iganga-Nawangisa road

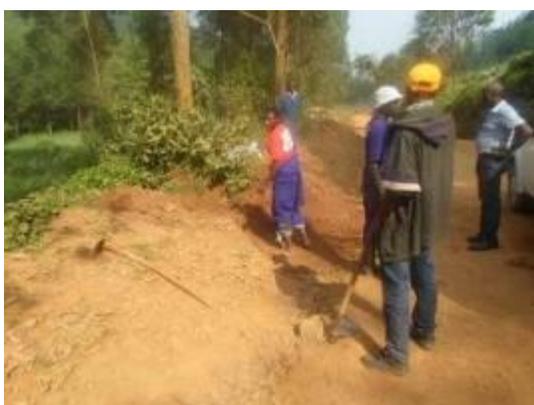
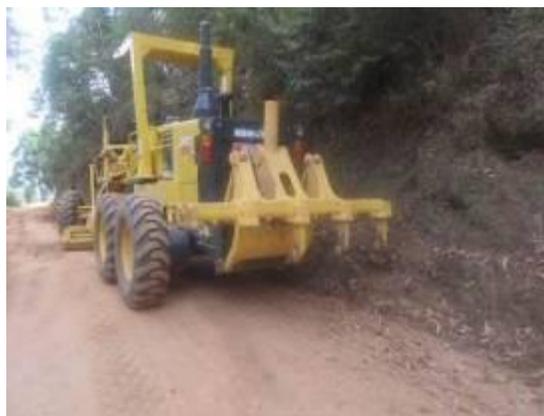
Hamurwa-Kerere-Kanungu Road (47km): The scope of works involved grading and spot - regravelling. These had been completed for cycle 2 while grading 21km had been completed under 3rd cycle. Works were ongoing.

The main challenge that was being experienced on this project was unavailability of gravel and long haulage distance.

Kabale UNRA Station: Left: Contractor’s workers digging off shoots at km 30+300; Left: Grader on site at km 42+100 for Hamurwa-Kerere-Kanungu road

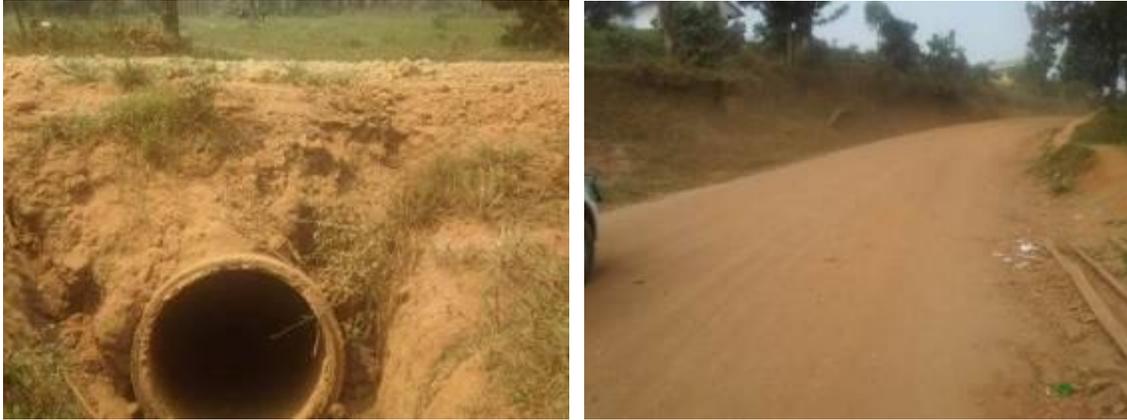
Kabale UNRA Station: Left: Incomplete culvert at km 20+600; Right: Completed section of the road for Kanungu-Kihihi-Ishasha road

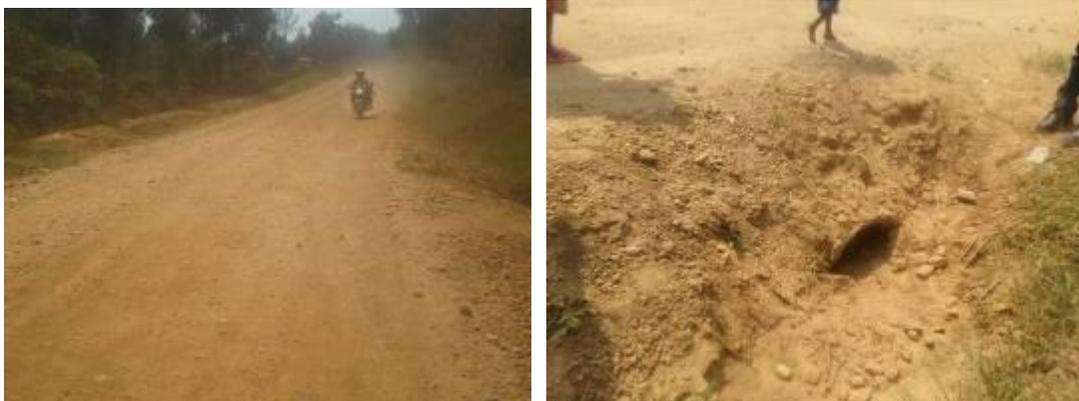
Kabale UNRA Station: Left: Graded section at km 14+700; Right: Culvert needs to be opened at km 7+000 on Katojo Kihihi road

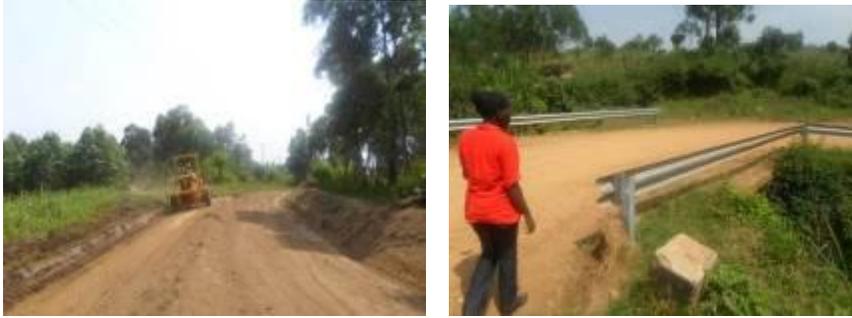
Kabale UNRA Station: Left: Grading along Rwerere - Bungangare road at km 7+900; Centre: Guard rails at km 2+000 Rwerere - Bugangare road

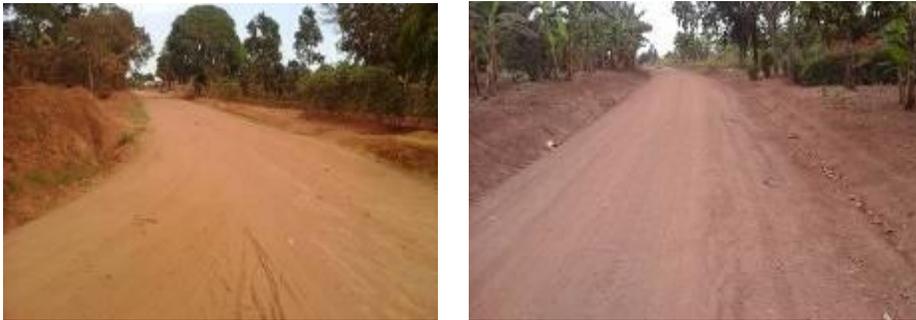
Masaka UNRA Station: L-R: Graded section at km 37+500 along Villa-Maria Sembabule, well gravelled section of Villa-Maria Sembabule road at km 27+400

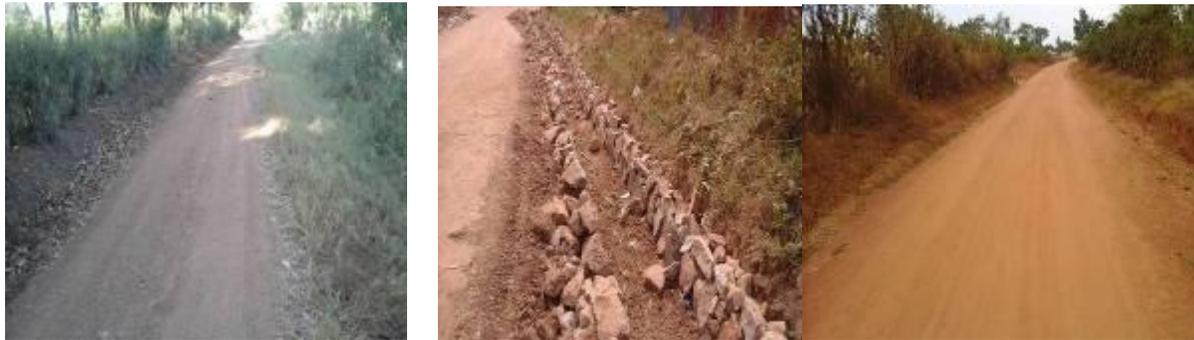
Masaka UNRA Station: Left: Completed section Ndegeya -PTC Access road; Center: Incomplete stone pitching works at km 26+300 along Lukaya-Miwula-Kagorogoro road in Mivula trading centre; Right: Gravelled section at km 1+700 along Lukaya-Miwula-Kagorogoro road

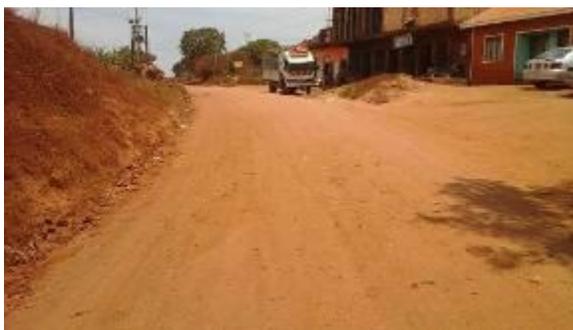
Masaka UNRA Station: Left: Gravelled section of Masaka-Bukakata road at km 0+100

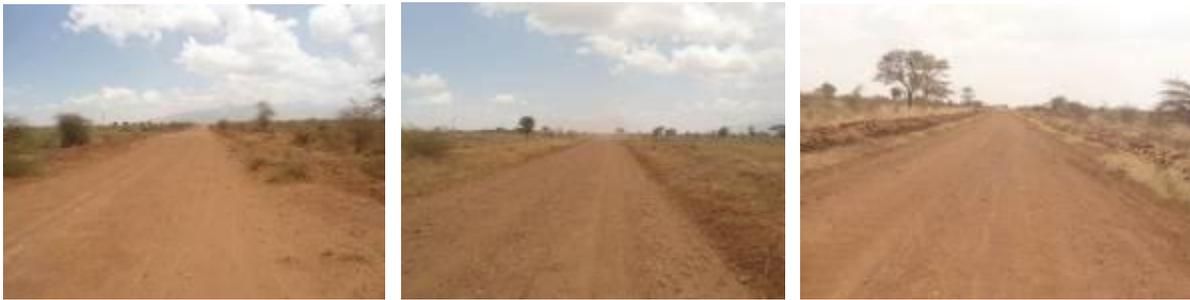
Moroto UNRA Station: Nadunget Iriri road (70km): Left: At Km 8+200; Centre: At Km 10+200; Right: At Km 22+500. A well graded and maintained road

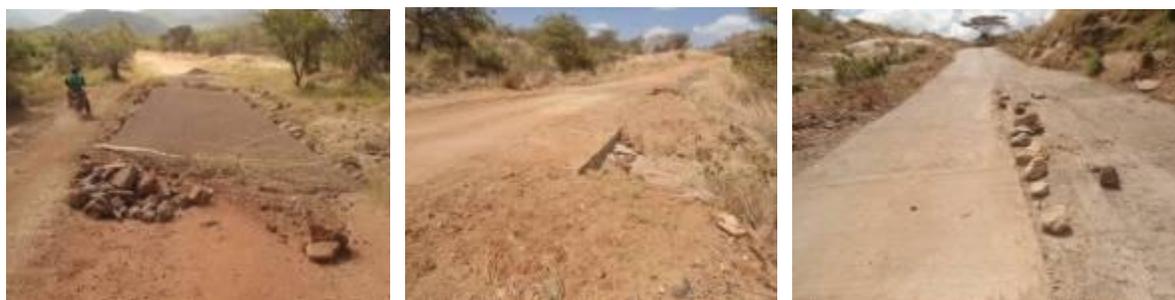
Moroto UNRA Station: Moroto-Rupa-Nakiloro-Nakabat road (28km): Left: Drift at Km 16+300; Centre: Drift at Km 20+100; Right: The 120m by 60m concrete pavement at the escarpment at Km 21+400

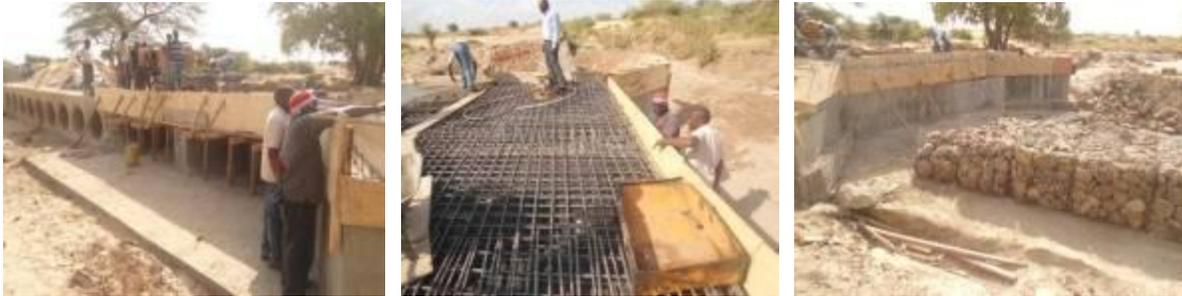
The scope of works involves the construction of a double cell box culvert, 2.5m by 1m, of grade C25 concrete and gabion protection works. The bridge works started in December 2014 and were still ongoing at the time of monitoring. The concrete works of the box culvert decking and construction of gabion protection works were ongoing at the time of monitoring. The grading works were going to be done in Q3. By the end of the Q2, Ug shs 115 million (74% of budget) had been released in the FY 2014/15 of which Ug shs 93.227 million (81% of release) had been expended. The physical progress of the works was estimated at 75% and the project was expected to be completed in two weeks time.

Moroto UNRA Station: Left: The existing drift with culverts and the new construction box culvert works with scaffolding; Centre: Reinforcement for the decking; Right: Gabion protection works at Naoi Bridge on Kokeris-Lopei road
