**THE REPUBLIC OF UGANDA**

## **Semi-Annual Budget Monitoring Report**

**Financial Year 2014/15**

**Water and Environment Sector**

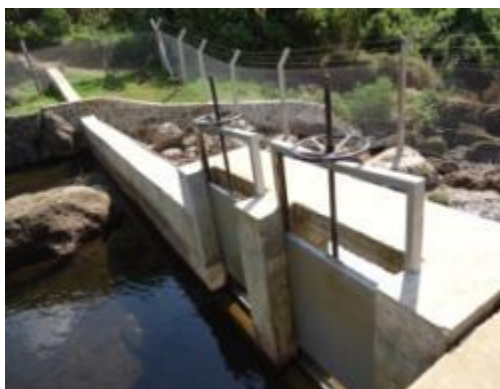
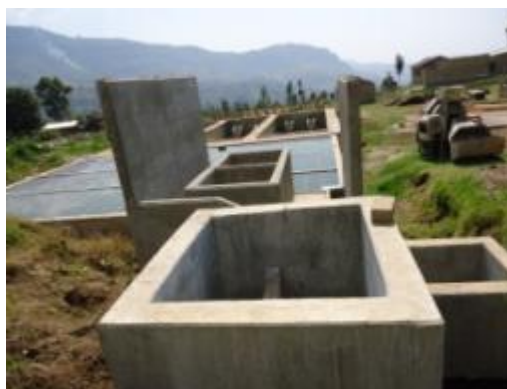
**Left: Completed retention weir in Bupoto sub-county; Right: Inlet chamber, alum dosing unit, coagulation and flocculation chambers, and sedimentation tank in Bukokho sub-county**

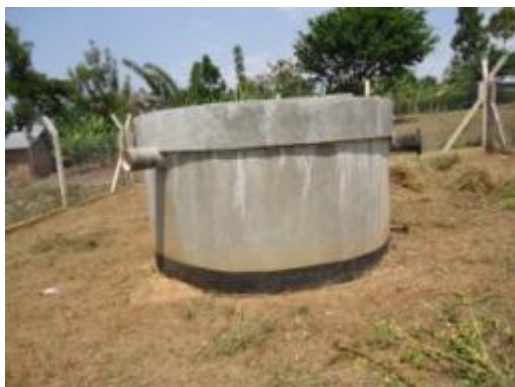
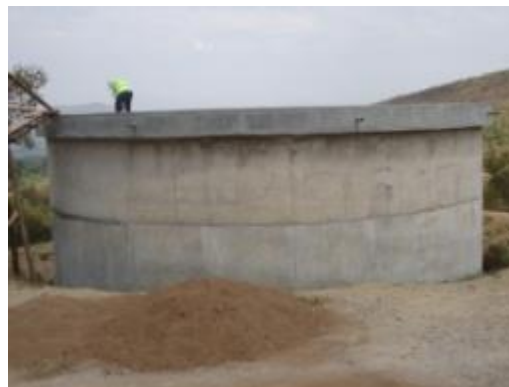
Left: 10m<sup>3</sup> BPT 4 in Magale sub-county; Right: 230m<sup>3</sup> reservoir tank in Butiru sub-county

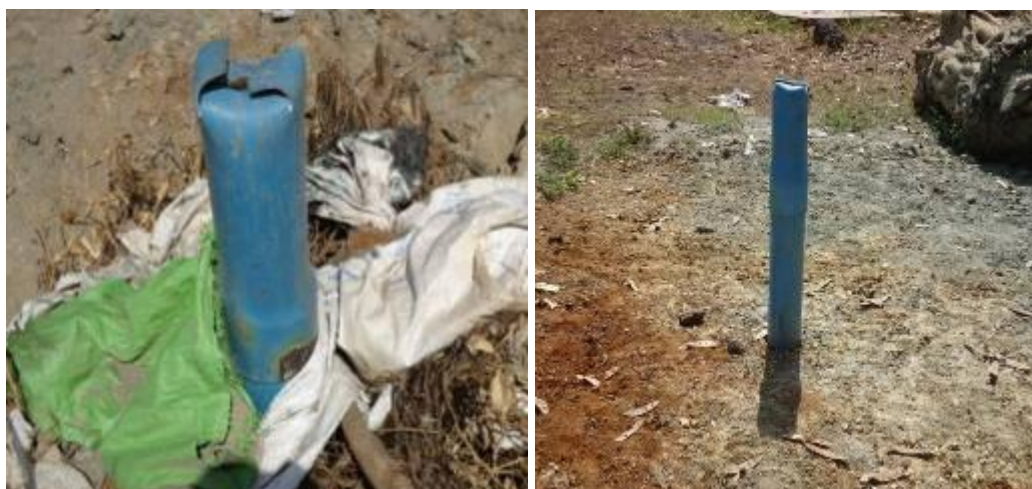
**L-R: Namungarwe borehole, Kawete village; Victory preparatory school borehole, Busano village Namungarwe parish (Iganga district)**

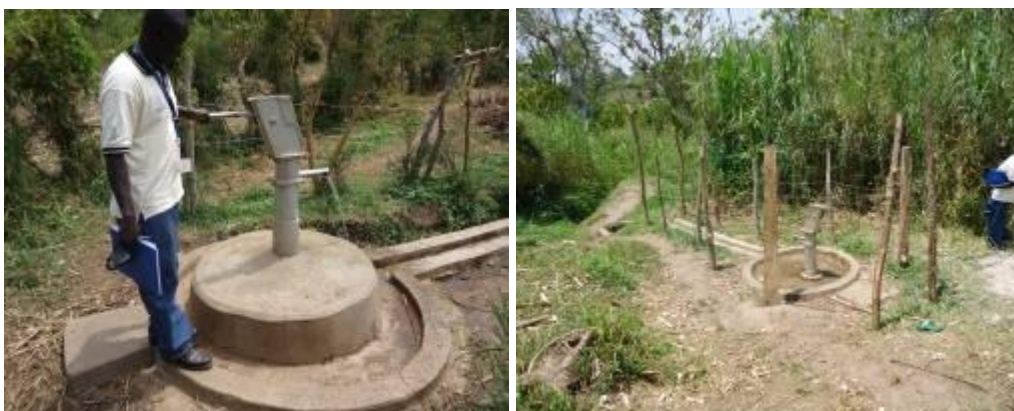
**L-R: Rehabilitated Karyinamwiru shallow well in Kyamunwa village, Kijweka Parish; Rehabilitated Katiganga shallow well in Busaiga village, Kyankaramata Parish (Kihura sub-county Kyenjojo district)**

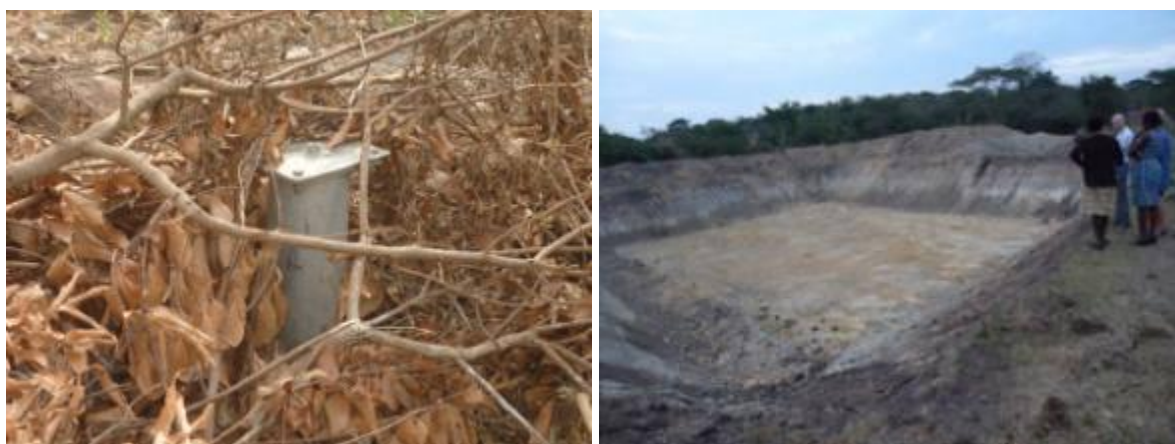
**L-R: Drilled borehole at Ntungamo village, Ntungamo parish Kabaringa sub-county; Rwemutongole village, Kawawa parish; 10,000m<sup>3</sup> valley tank in Manyogaseka (sub-county Mubende district)**

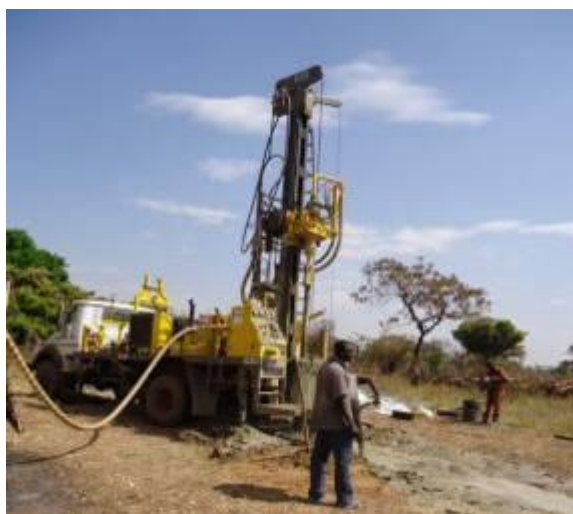
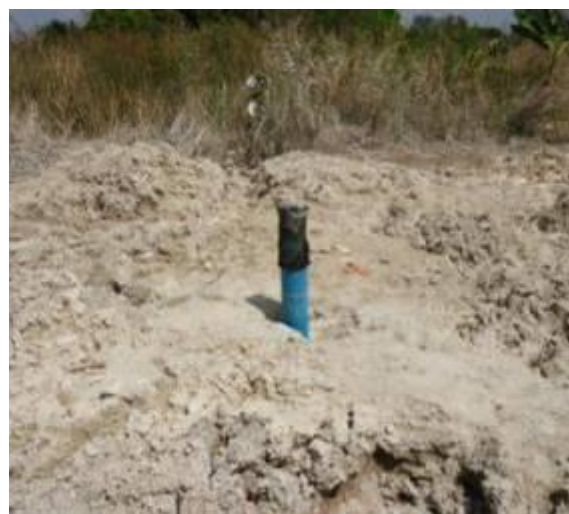
**L-R: Drilling works of Pagwari West, Lagwai parish, Achoro parish; Dognam East borehole, Lagwari parish (Pader Town Council in Pader District)**

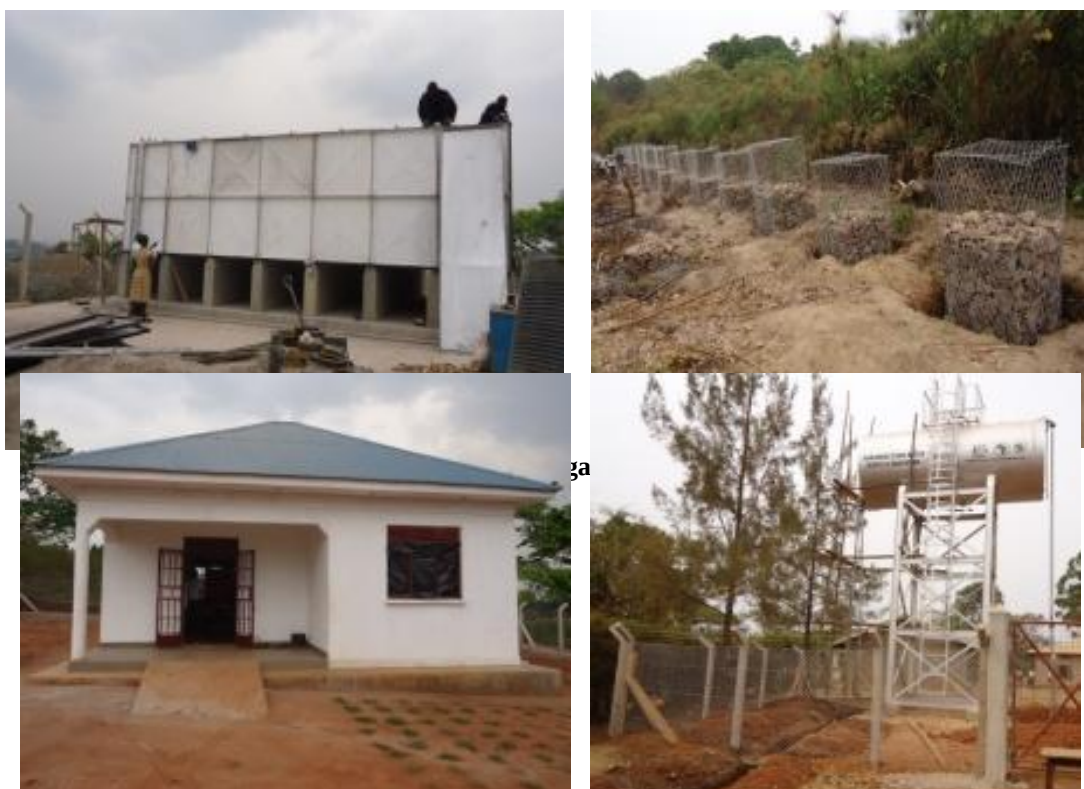
| Planned Outputs | Status / Field findings | Remarks |
|---|---|---|
| Water office<br>Construction of water office block with inbuilt water borne toilet, and equipping the office with furniture.<br><br>Landscaping and fencing of office block premises. | The water office with inbuilt water borne toilet was 99% complete, landscaping and fencing were finished.<br><br>Pending works were: Fitting of window glass panes, power extension and supply of furniture. | The water office structure had developed several cracks on the wall and verandah which need reinstatement. |

**R-L: Water office in Kakumiro town council; 20m<sup>3</sup> reservoir tank at Kanyawawa Primary School**

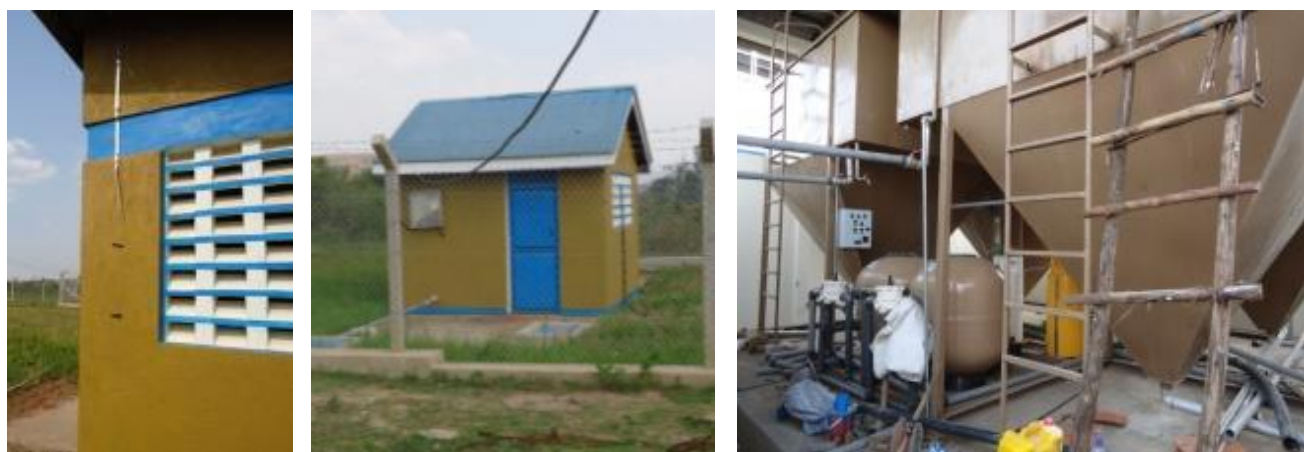
**Left: Vandalized lightning conductor at Ginnery pump station; Centre: Renovated pump house at Abukol spring; Right: Dayliff treatment plant on Kachumbala mission hill**

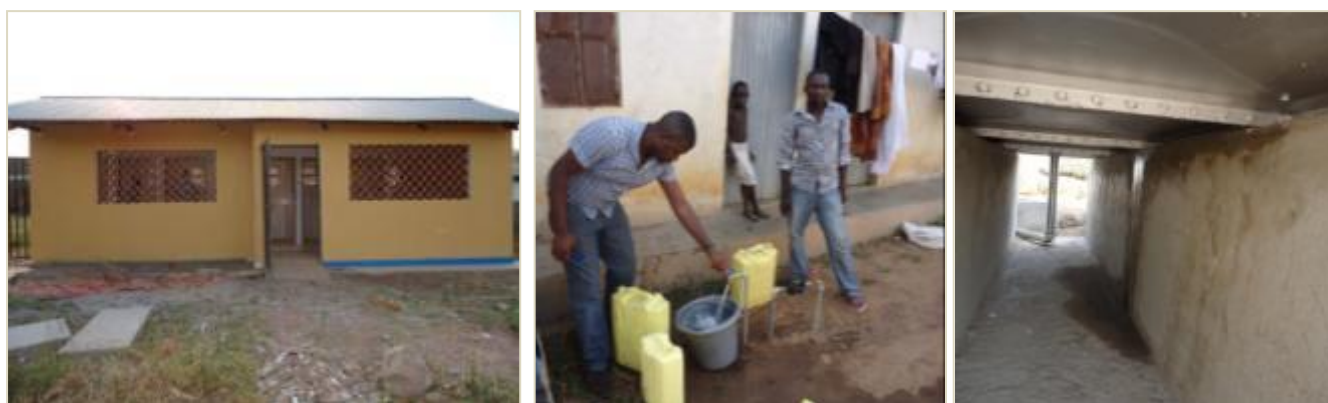
| Planned Outputs | Status / Field findings | Remarks |
|---|---|---|
| <p>Reservoir tank</p> <p>Supply and installation of 50m<sup>3</sup> steel reservoir tank on dwarf walls.</p> | <p>A 50m<sup>3</sup> cold pressed steel water reservoir tank was supplied and installed on dwarf walls.</p> | <p>The reservoir tank was undergoing leakage testing. Leakage was observed at the bottom of the tank.</p> |

**Left: Water borne public toilet in Ocheri town; Centre: Functional household private tap in Ocheri town; Right: Leakage underneath the reservoir tank on Ocheri hill**

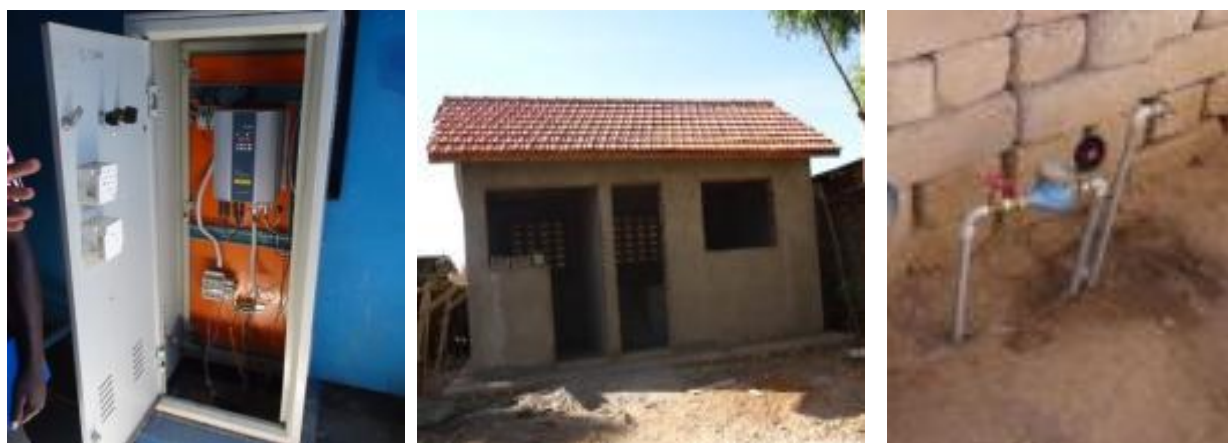
**Left: Solar control at the pump station in Matany town; Center: Chlorine house in Matany town; Left: Household private tap in Matany town**

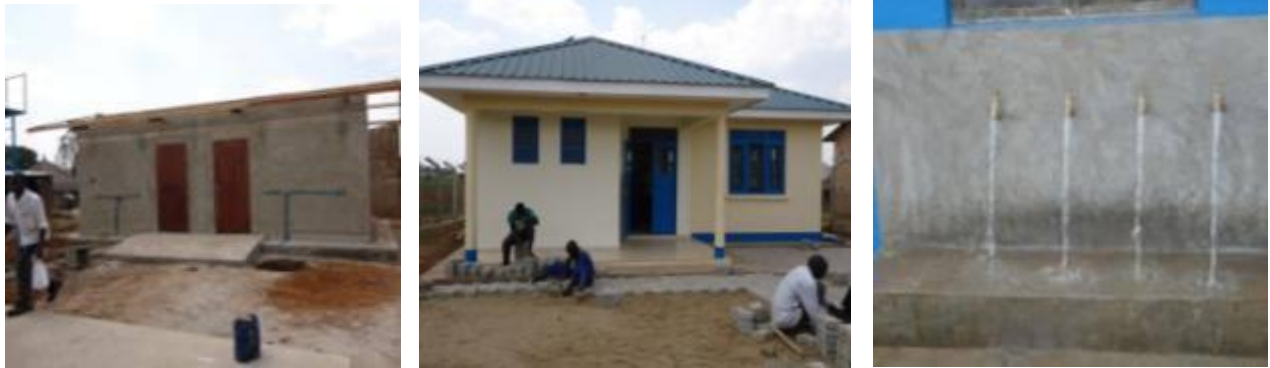
**L-R: Water borne public toilet, ongoing landscaping at the water office and a public water kiosk, all at Purongo trading centre**

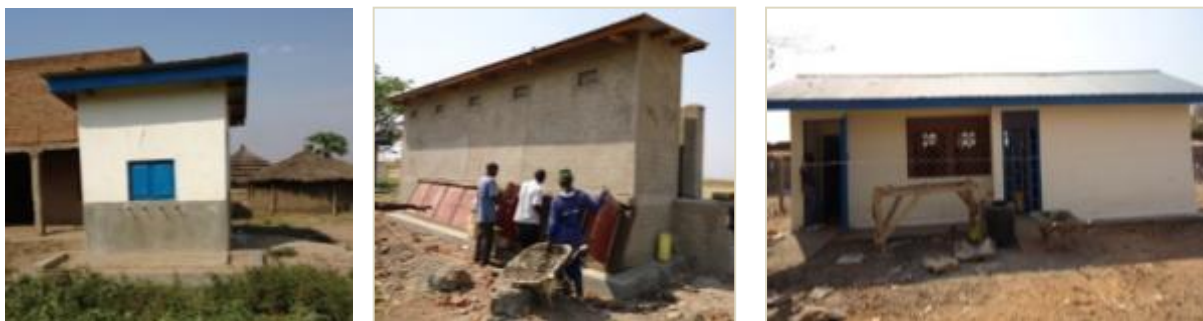
**L-R: Public water kiosk in Patongo TC; Ecosan toilet in Moo Dege P/S; public water borne toilet in Patongo Taxi Park**

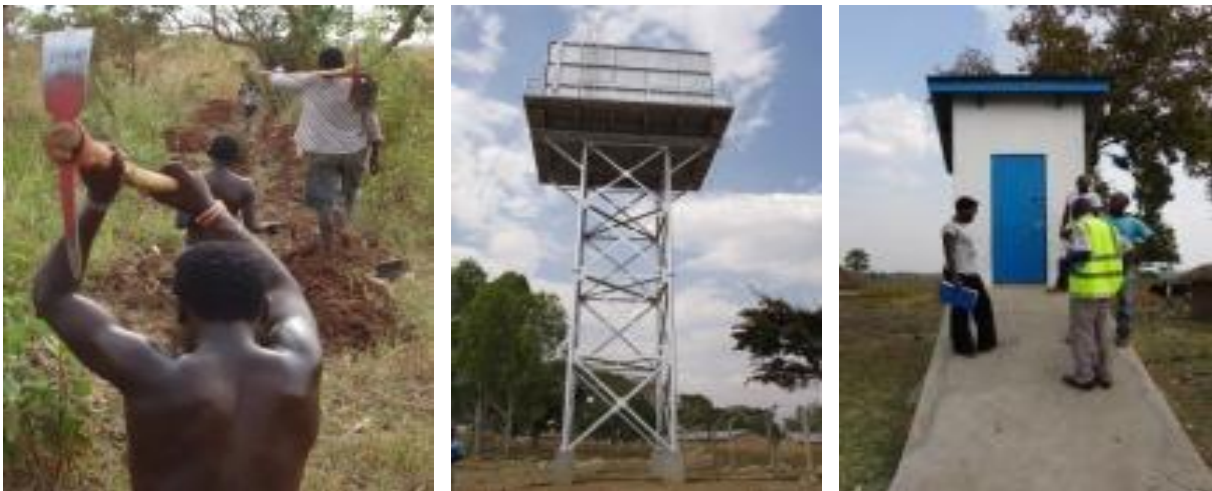
**L-R: Trenching transmission mains; 100m<sup>3</sup> reservoir tank; Household ecosan toilet all in Lakwana sub-county**

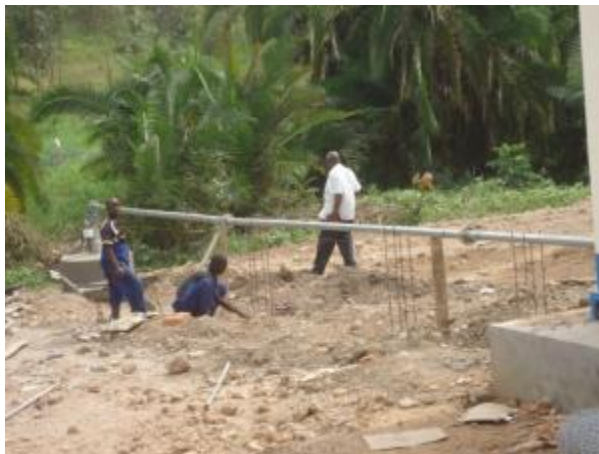
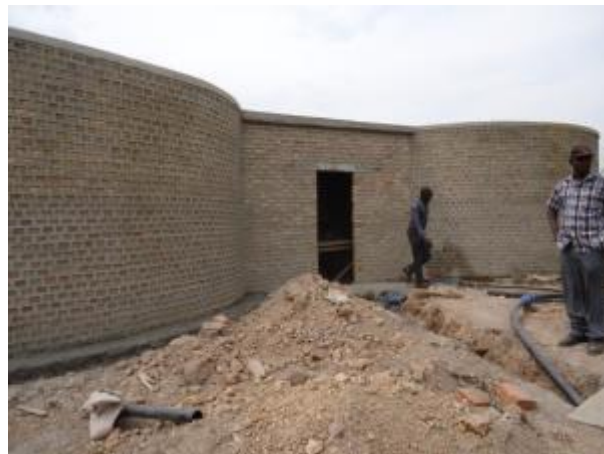
**L-R: Anchoring of pumping main; 120m<sup>3</sup> twin reservoir tank both in Kijongo sub-county**

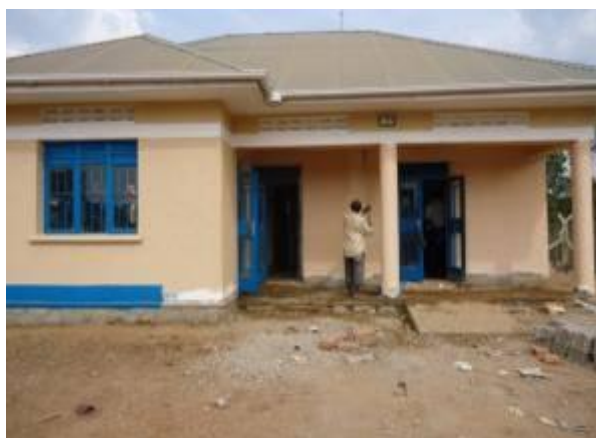
**L-R: Painting of the water office ongoing; Water office furniture in Kijongo sub-county**

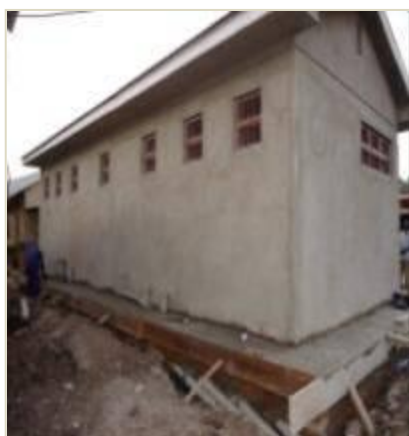
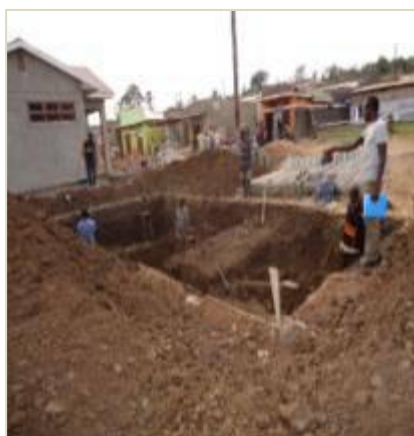
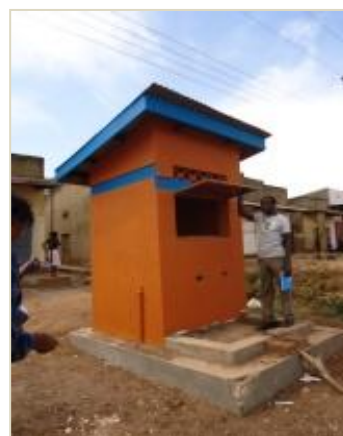
**Left: Water borne public toilet: Center: Excavation of septic tank: Right: Water kiosk**

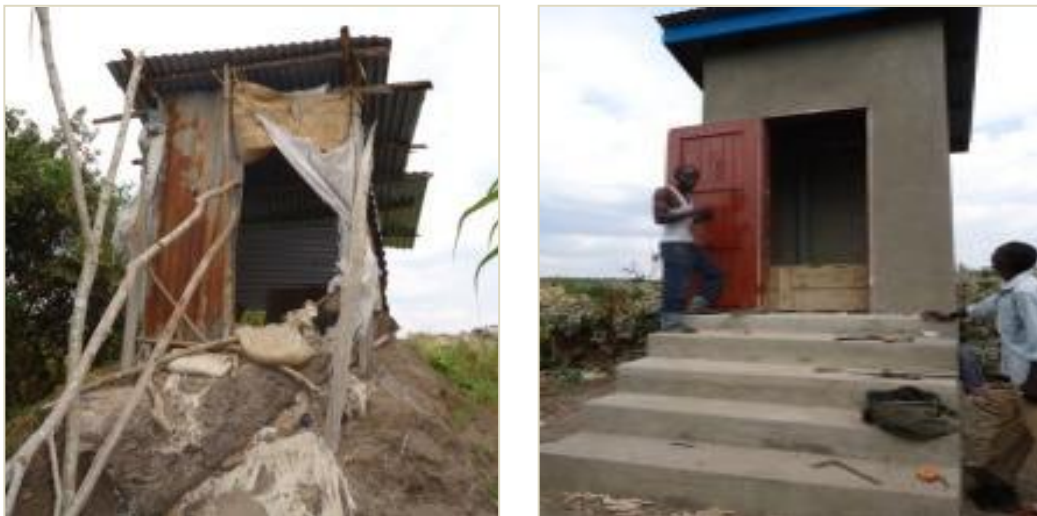
Mr. Adonia was originally having a makeshift toilet which he had constructed on a mud hill (selfmade) due to the high water table in the area. The toilet was being used by his household and customers of his restaurant business.

**L-R: Make shift pit latrine and new household ecosan toilet at Mr. Adonias' residence Kinoni trading centre**

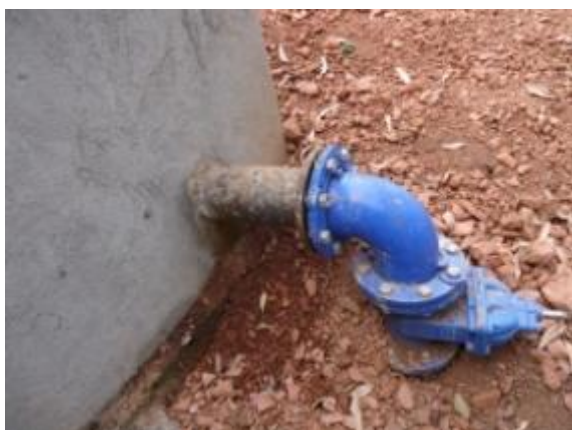
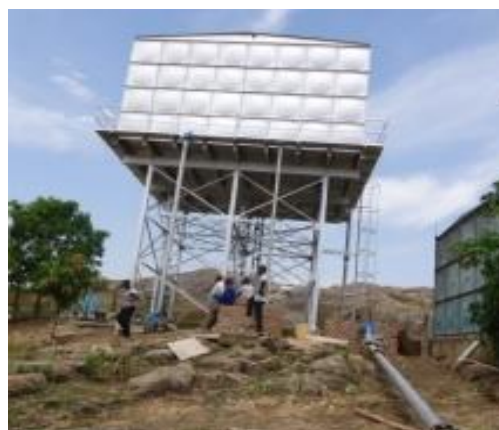
**L-R: Leakage on 8m<sup>3</sup> BPT; 250m<sup>3</sup> reservoir tank in Lyantonde Town Council**

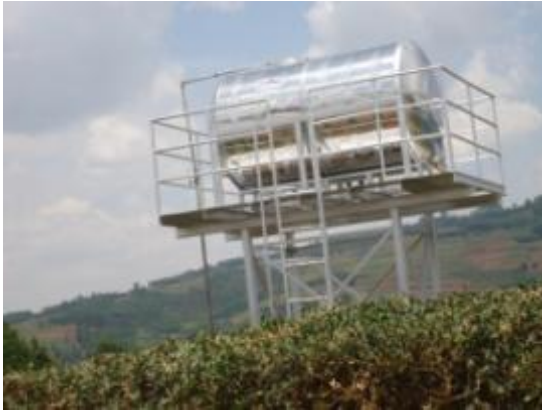
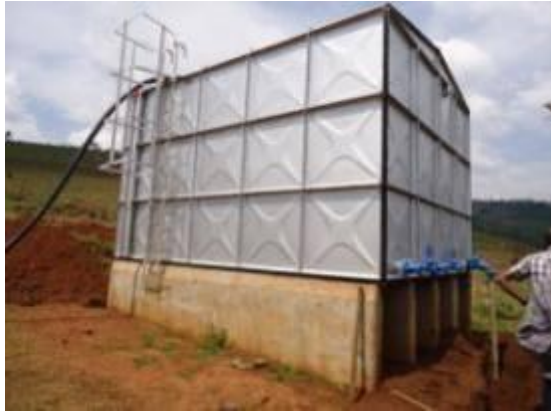
**L-R: 5m<sup>3</sup> institutional reservoir tank and 50m<sup>3</sup> main reservoir tank on Rushoroza Hill**

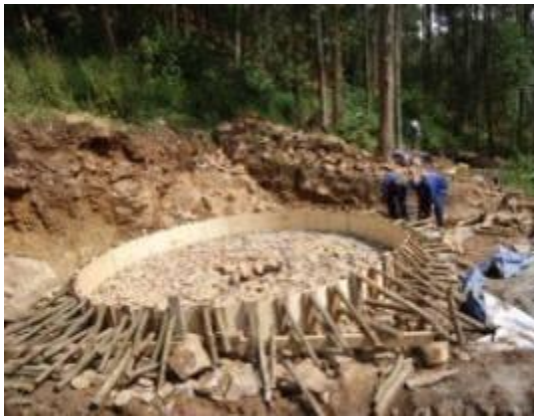
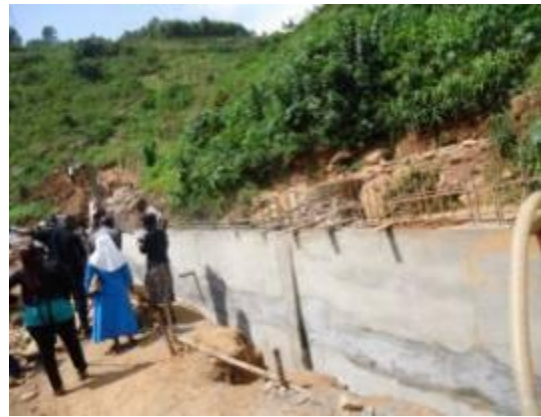
**L-R: Foundation works of 40m<sup>3</sup> concrete reservoir; Retention wall at intake on Rushoroza Hill**

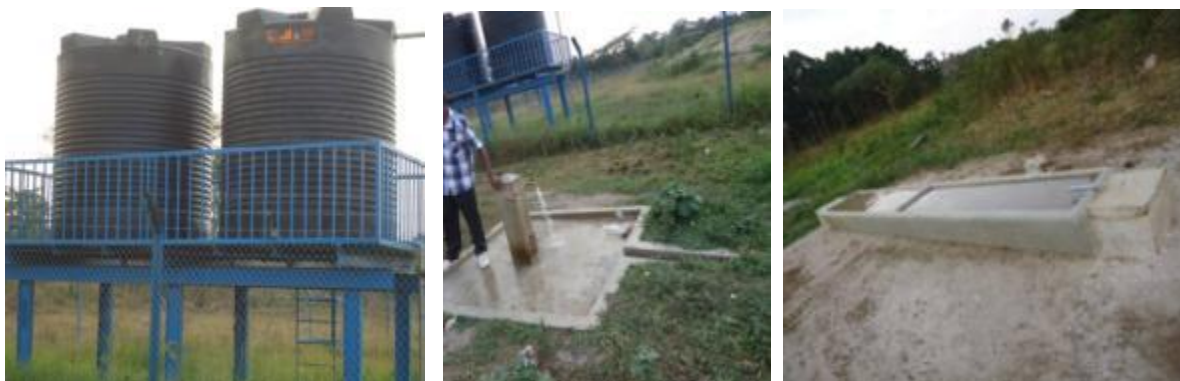
The four cattle troughs were constructed. The water is pumped from the valley tank by use of a suspended pump which was operated by solar energy. The water is then sent into two overhead plastic crest tanks and then into the troughs and service tap. The dam was secured with a chain link fence and a gate. A one block-four stance drainable VIP latrine (with for male and female section) was also constructed.

**L-R: Reservoir tanks; Public water stand post; Cattle trough in Ruyonza sub-county**

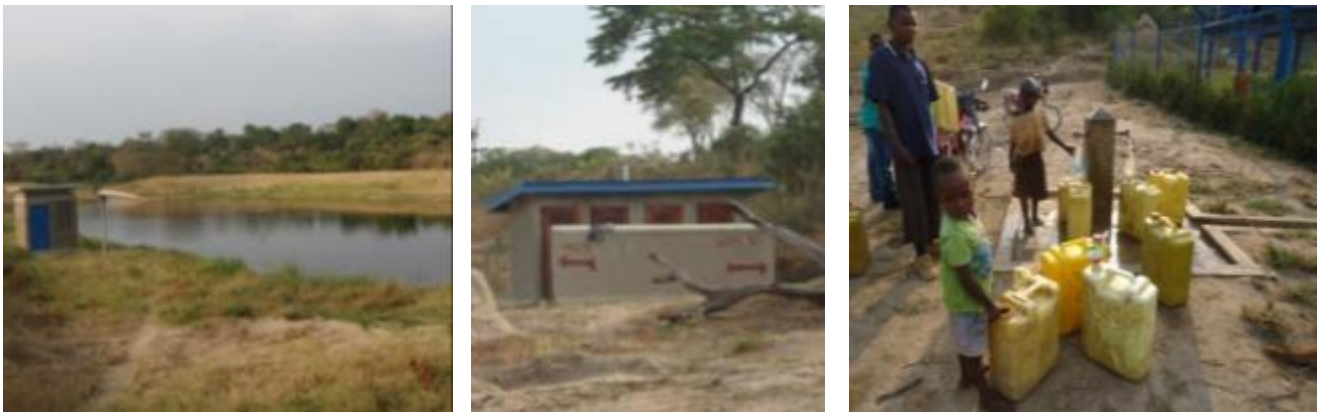
The water is pumped using a suspended pump which is operated by solar energy. A communal public stand post was constructed. The dam was secured with a chain link fence and a gate. A one block-four stance drainable VIP latrine (with for male and female section) was constructed.

**L-R: Pump house & Valley Tank; Public VIP latrine; Public water stand post in Ruyonza sub-county**

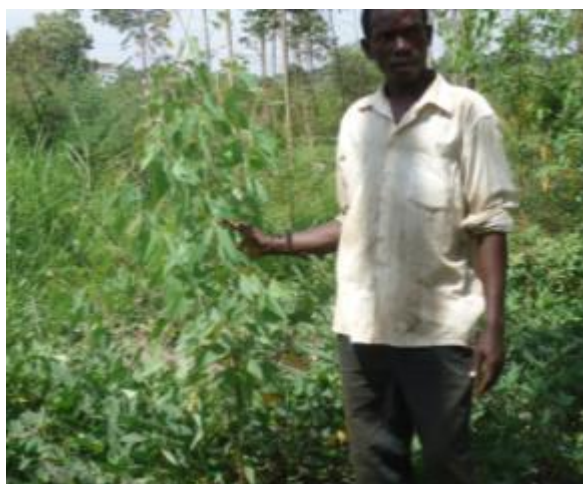
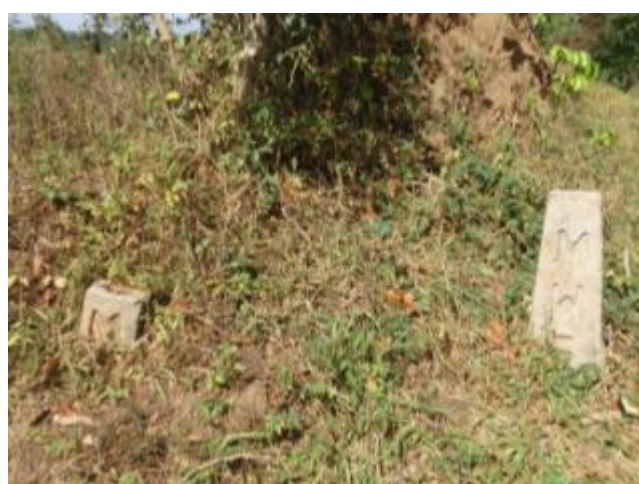
Planted eucalyptus tree during Q1 and marking stones for forest reserve (short) and water-point at highest inclination level (tall)

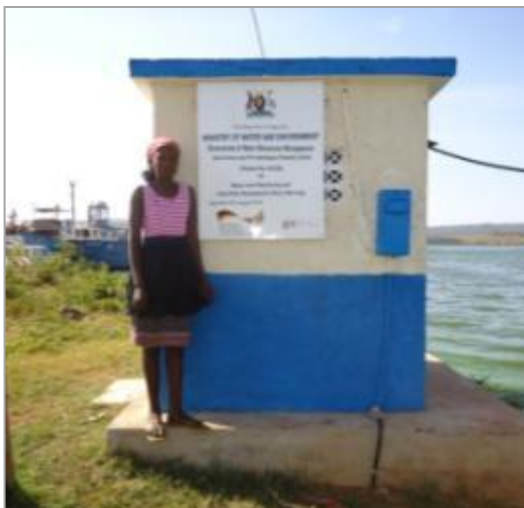
The finished civil works involved putting up the structure which is the protection/transmission house. This reduces the sensitivity of the equipment as it is sheltered under room temperature. The stilling well below the house gives the actual levels of the lake was installed. Remaining works are connecting to power and the base station in Entebbe.

**Completed protective house**

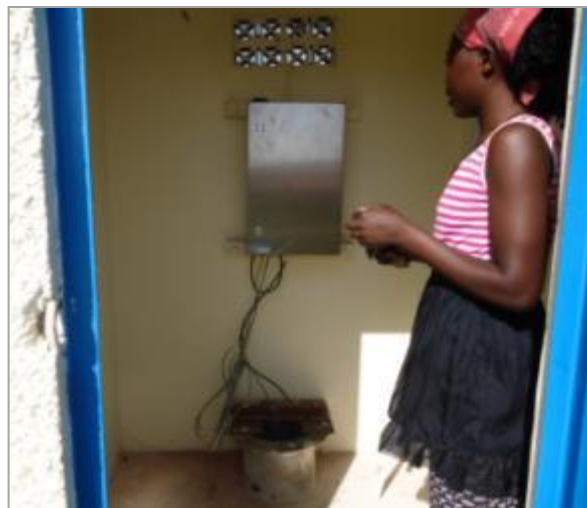
**Installed equipment**
